Slow strain rate stress corrosion cracking behaviour of as-welded and plasma electrolytic oxidation treated AZ31HP magnesium alloy autogenous laser beam weldment

In: Materials Science and Engineering A (2009) Elsevier

P. Bala Srinivasan^{*}, S. Riekehr, C. Blawert, W. Dietzel, M. Koçak

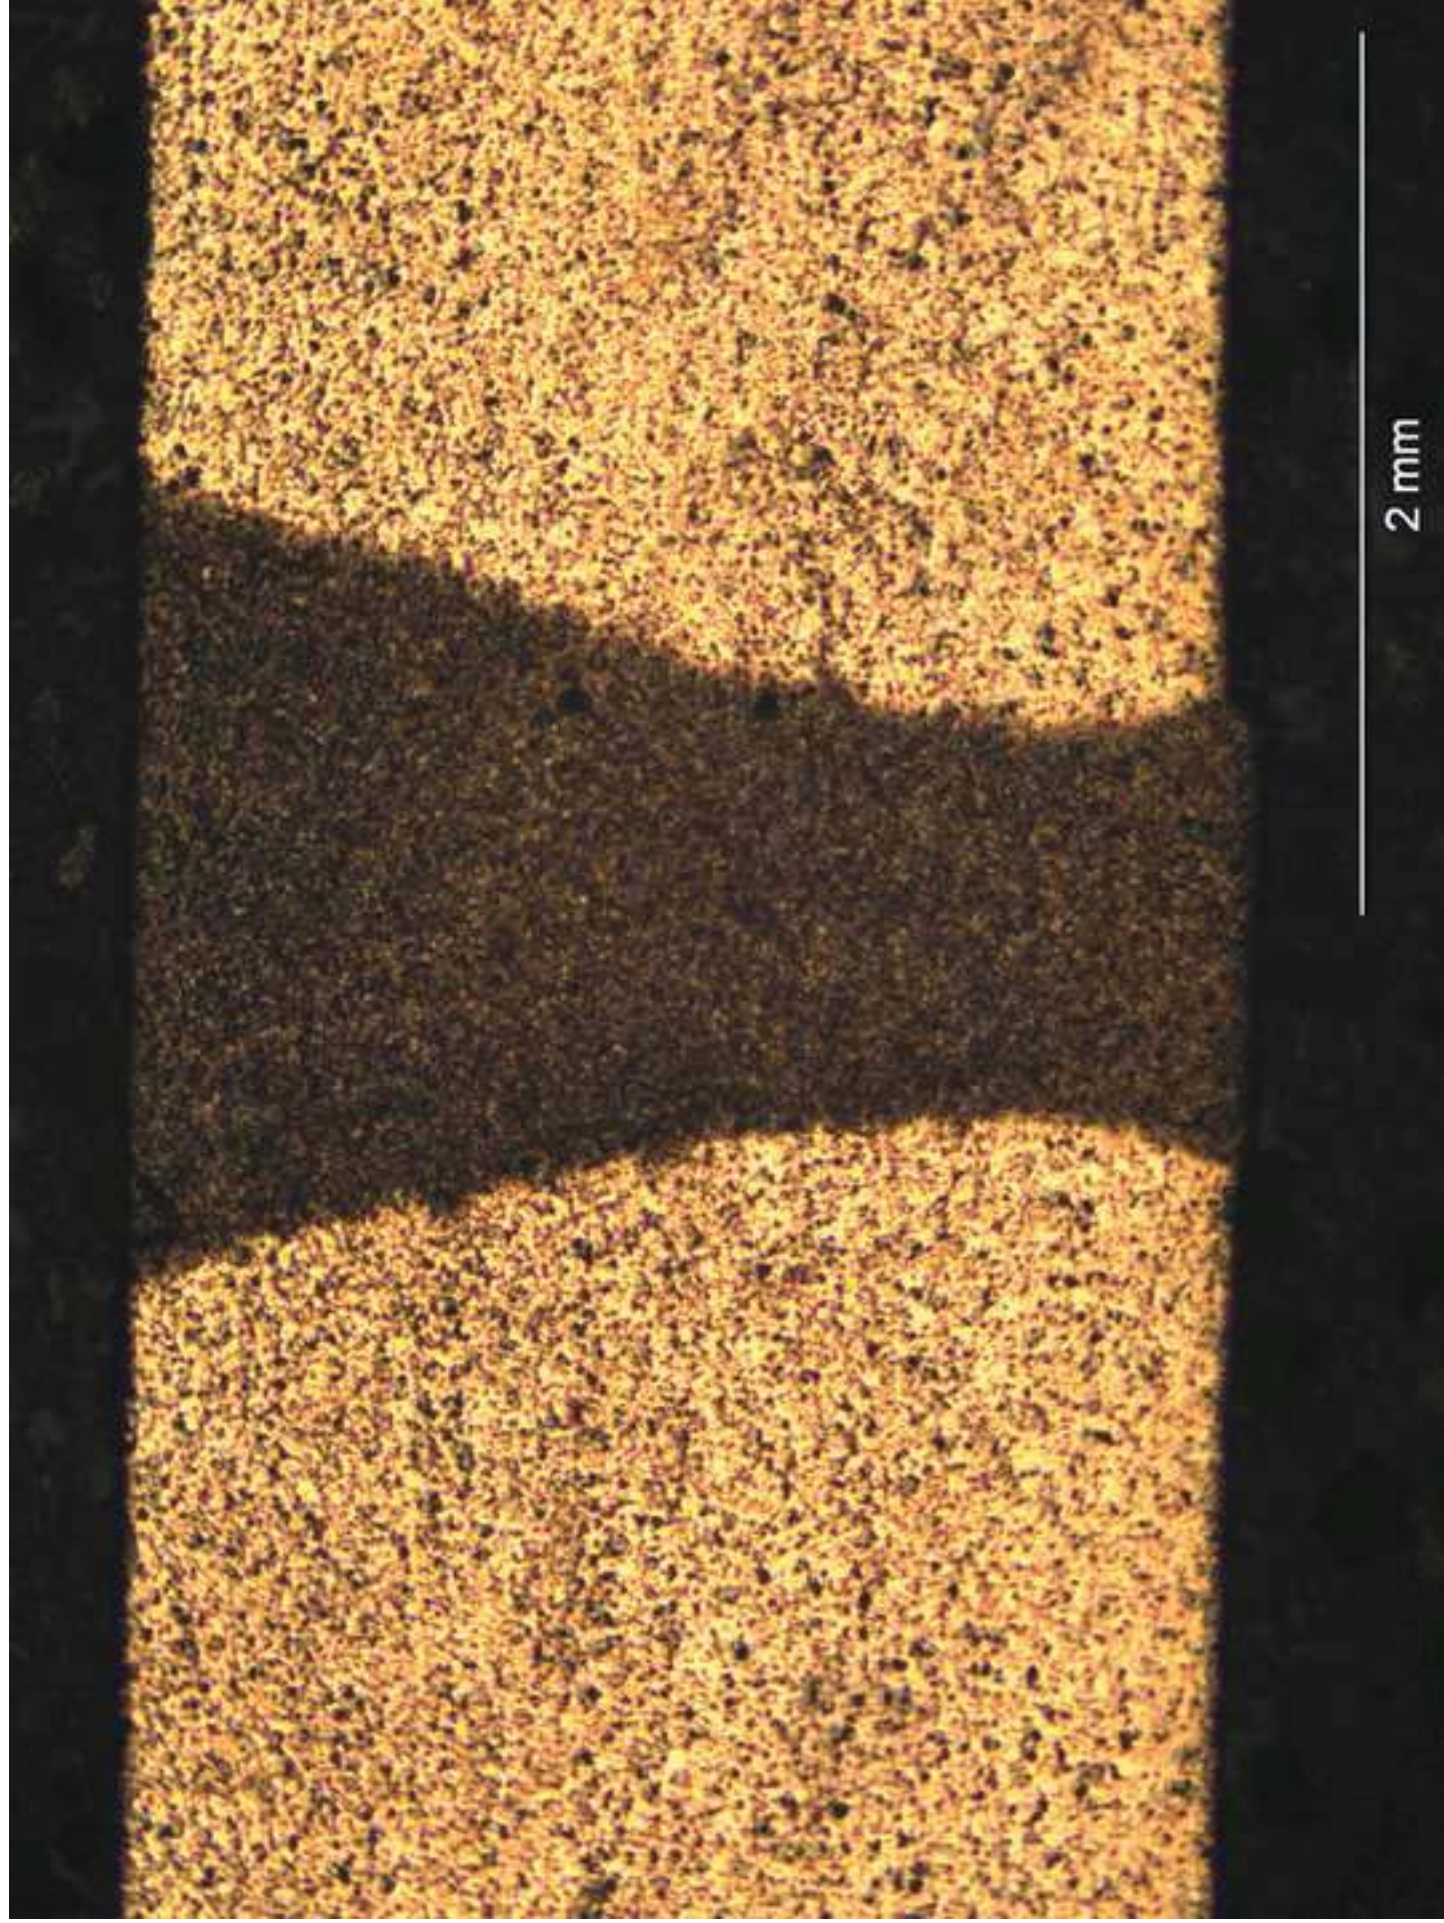
Figure 2
[Click here to download high resolution image](#)

The optical macrograph of the laser weldment shown in Figure 2 reveals a wine-glass shaped bead with a maximum width of approximately 2 mm at the face region of the weld and 1 mm at the root. As is expected in a laser weldment, no distinct heat affected zone is visible in this macrograph. However, the weld bead contained a few tiny pores, which are characteristic in laser beam magnesium alloy welds.

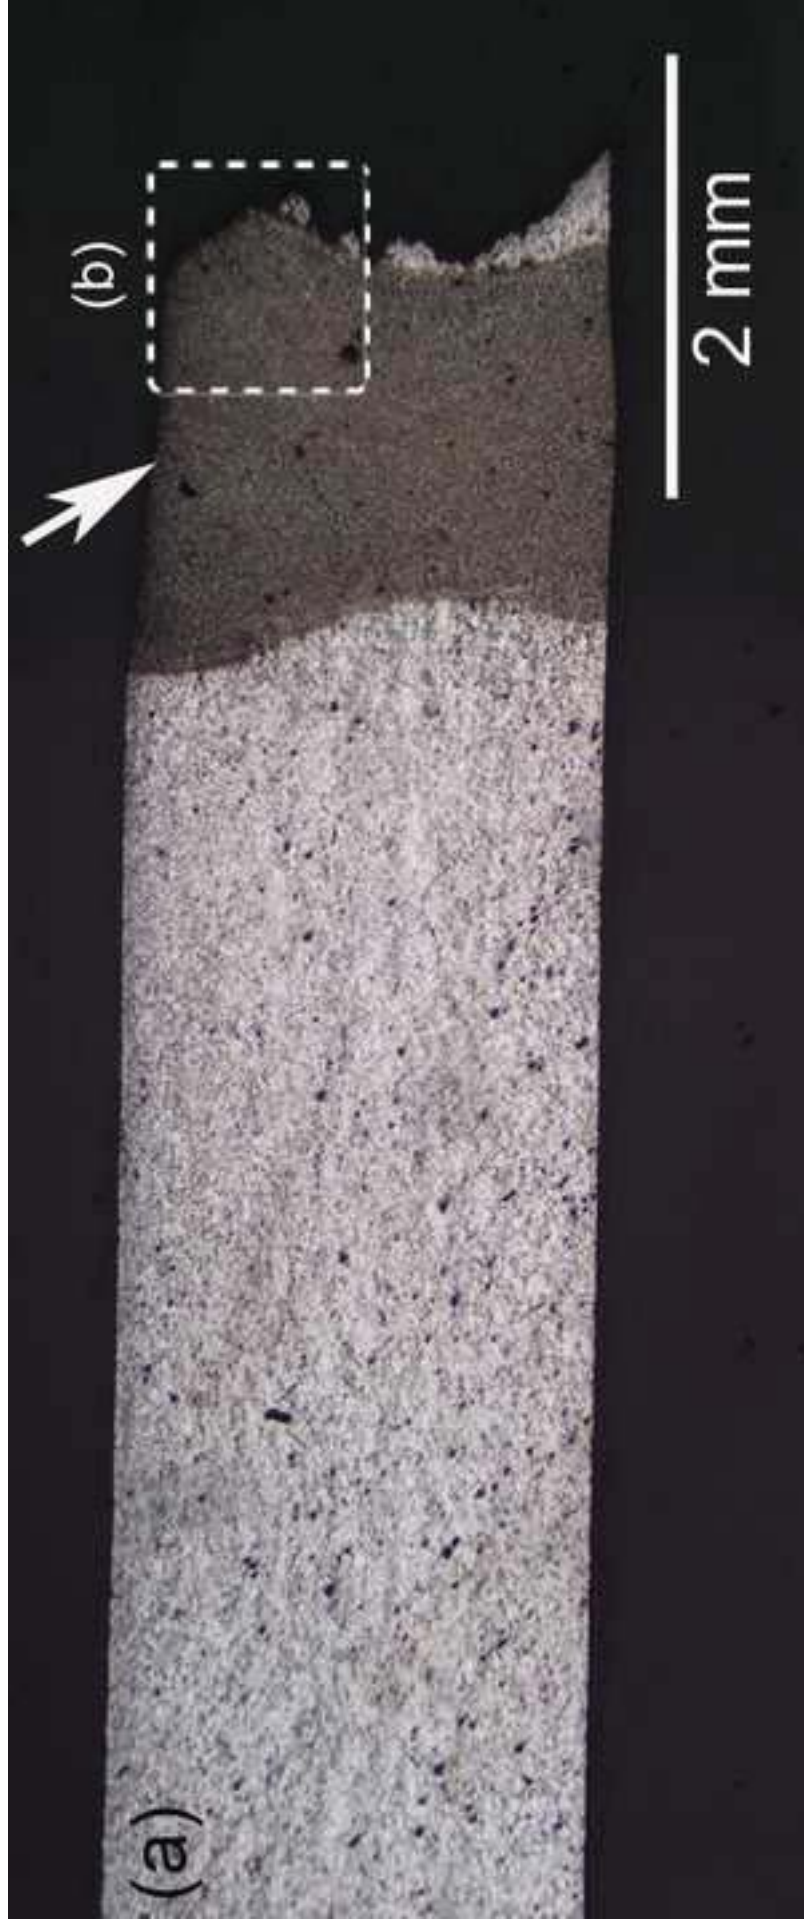
Figure 4a
[Click here to download high resolution image](#)

Figure 4(a) shows the optical macrograph of the weldment specimen SSRT tested in air. The reduction in the section thickness in the weld metal region, leading to necking and fracture is evident in this macrograph. The higher magnification micrograph (Figure 4(b)) obtained from the face region of the weld shows that the specimen had fractured along the HAZ region near to the fusion boundary. It is interesting that the weld metal showed good mechanical properties despite the presence of isolated small pores. It appears that the weld metal and fusion boundary/HAZ were the weakest regions in this weldment, hence the deformation and the consequent fracture had

- Figure 4 Optical macro/micrographs of the SSRT tested weldment specimen (in air)
(a) overview (arrow shows region of necking)
(b) fracture location in the face of weld metal (higher magnification of region marked (b) in (a))

occurred in these regions. The weld metal region with a fine-grained structure probably had a better ductility comparable to that of the parent alloy. However, the early fracture and relatively low values of ductility parameters viz., apparent strain and RA observed for the weldment can be attributed to the damage initiation and growth in the coarse grained HAZ, as is evident in Figures 4(a) and (b).

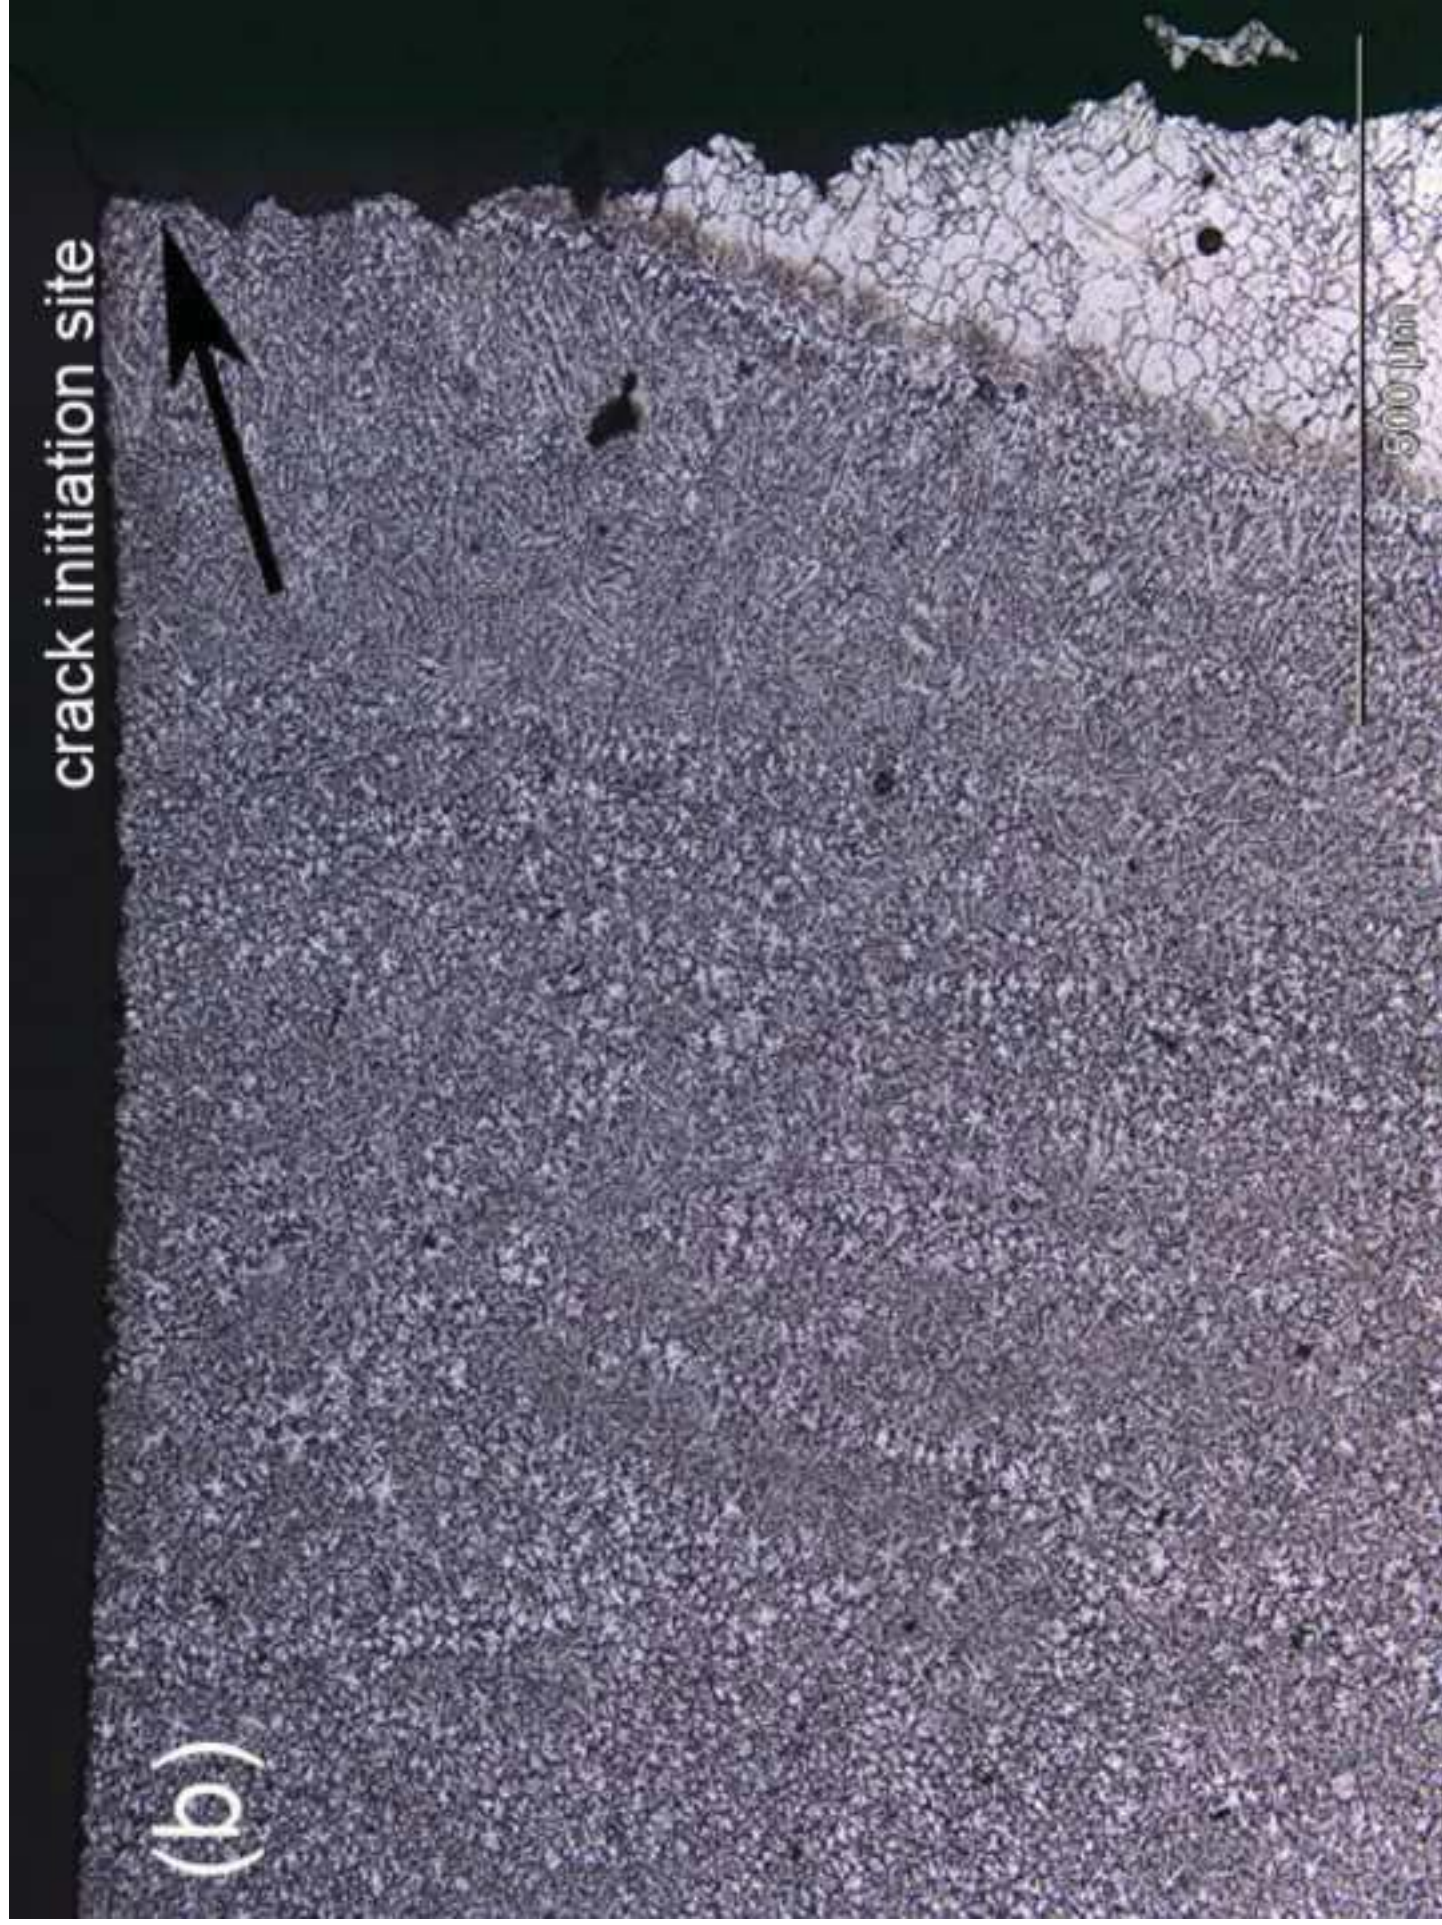
Figure 6b
[Click here to download high resolution image](#)

(a) overview
(b) fracture location in the face region of weld metal
(c) crack in the weld metal in the root region
- Figure 7 Scanning electron fractographs of the SSRT tested specimens (in ASTM D1384 solution)

The optical macrograph of the SSRT tested weldment specimen in ASTM D1384 solution is shown in Figure 6(a). Even though a crack was observed in the parent alloy, the specimen had failed in the weld metal/HAZ region. The deformation of the weld metal as a result of straining can be seen in the root region of this weldment. It may appear from this macrograph that the fracture was along the fusion boundary/HAZ as was observed in the case of the test in air. But, the higher magnification micrograph obtained from the face region of the weld shown in Figure 6(b) reveals that the crack initiation was in the weld metal near to the fusion line. A closer examination of this fractured specimen showed a crack in the weld metal in the root region (Figure 6(c)) as well, and this observation further reaffirms the fact that the weld metal has a higher susceptibility to SCC in this weldment. It is probable that during the straining/deformation of the weld metal, micro cracks had developed on the surface, due to the cracking of surface oxide/hydroxide layers, which subsequently might have led to the propagation of crack and premature fracture. The scanning electron fractographs of the parent and weldment specimens shown in Figures 7(a) and (b), respectively, reveal a brittle fracture in transgranular mode in both the cases. The fracture surface of the weldment specimen looks a little different from that of the parent, and this was possibly the result of the inadvertent longer exposure of the fractured specimen to the SCC test electrolyte after the tests.

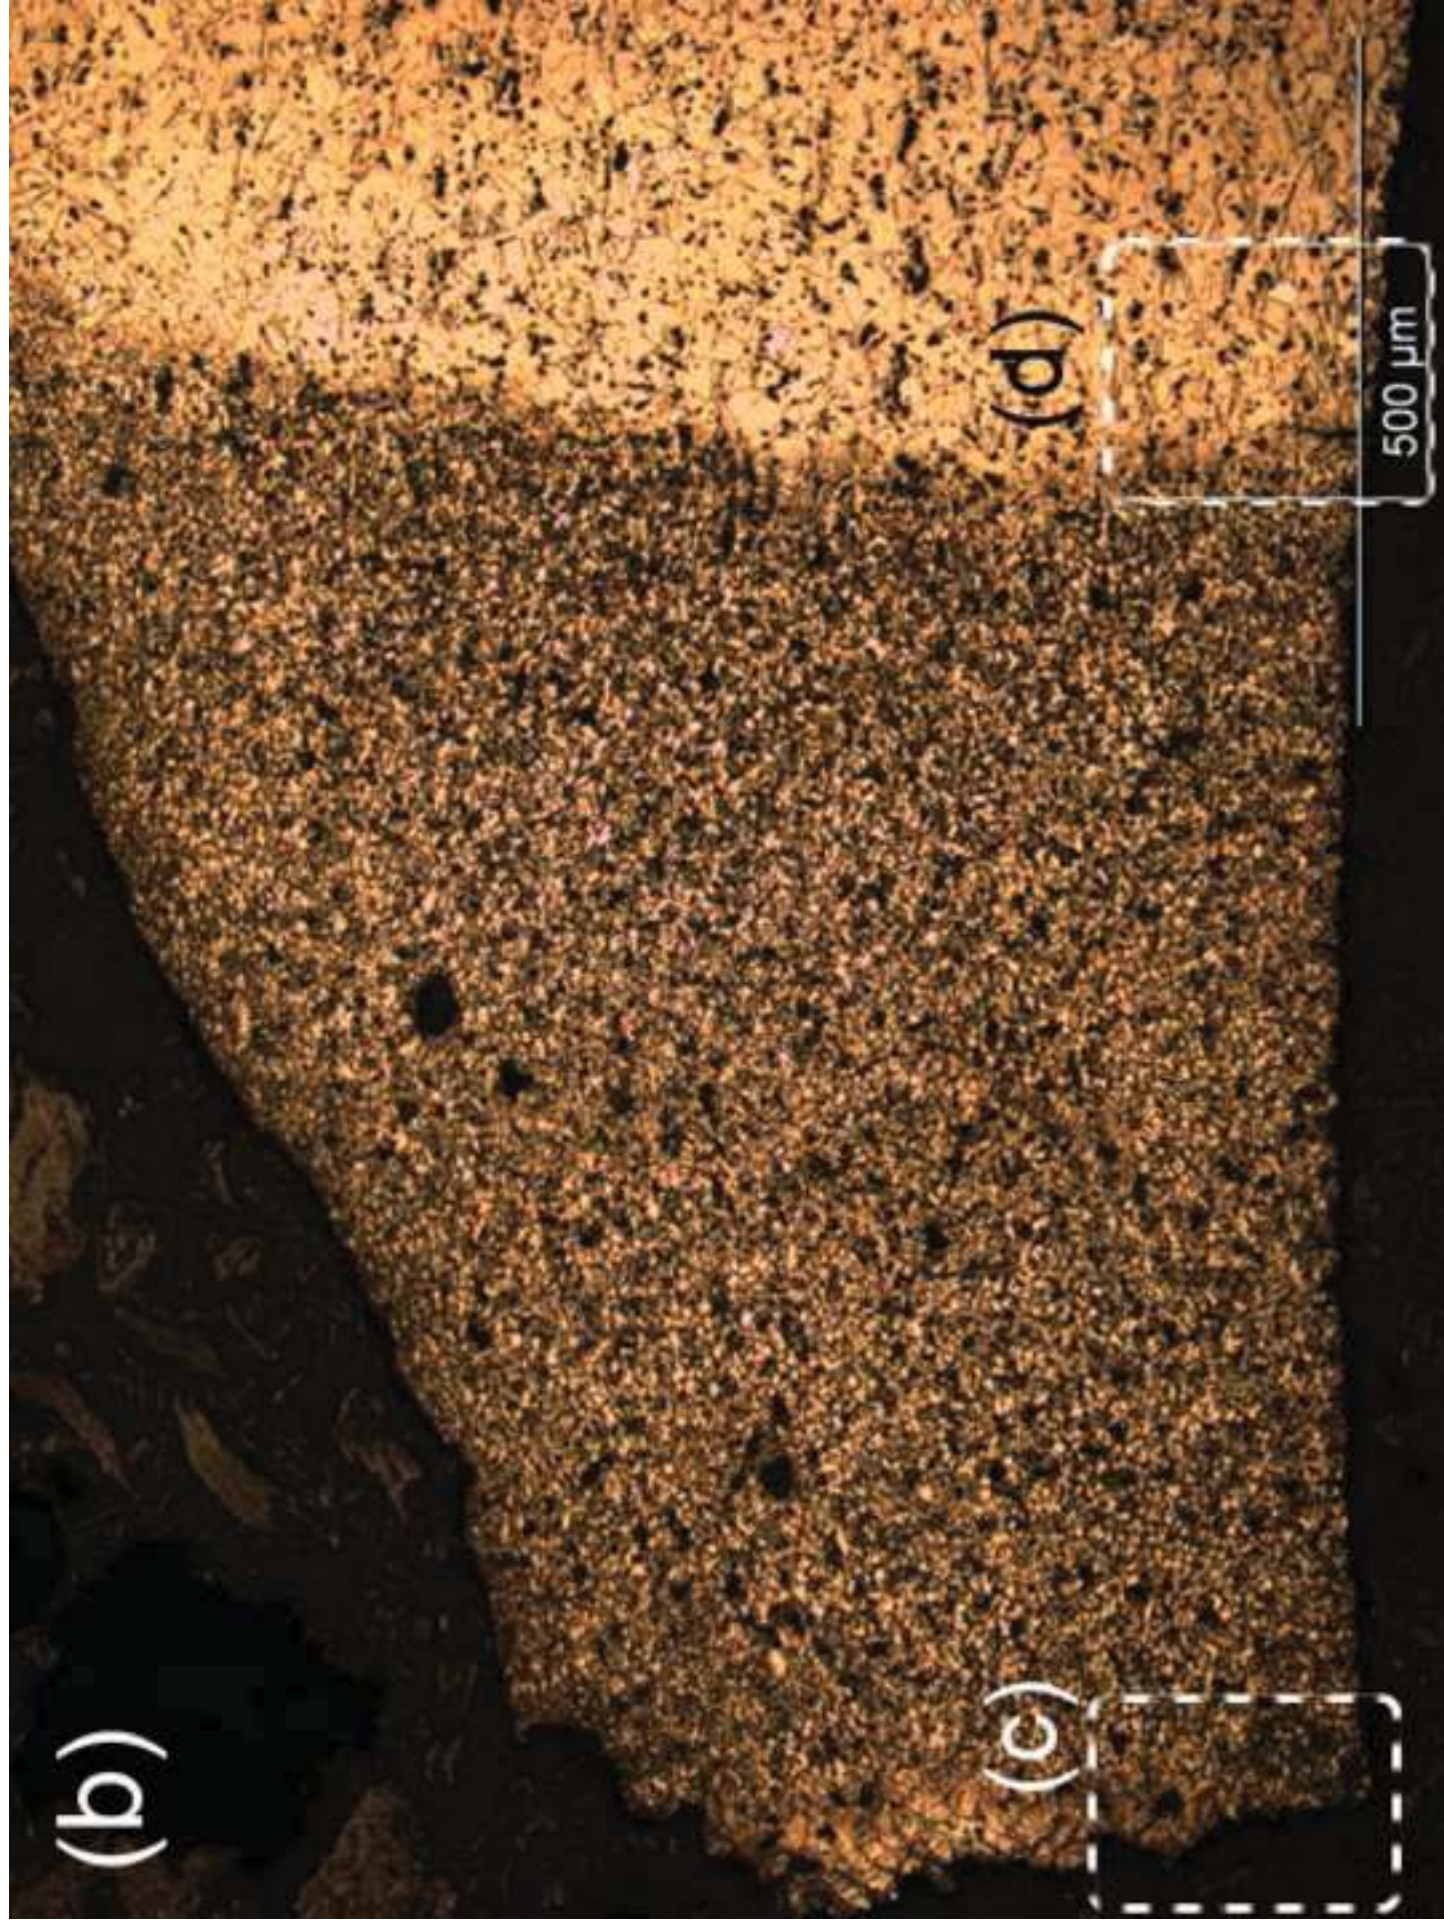
Figure 10b
[Click here to download high resolution image](#)

metal region to SCC even in the coated condition is illustrated by the higher magnification micrographs in Figure 10(b) and (c). The presence of a crack in the HAZ close to the root region of weld suggests that the weld metal to be the vulnerable region for SCC (Figure 10(d)).

(b) higher magnification micrograph of region marked in dotted square in (a)
(c) higher magnification micrograph of region marked in dotted square in (b)

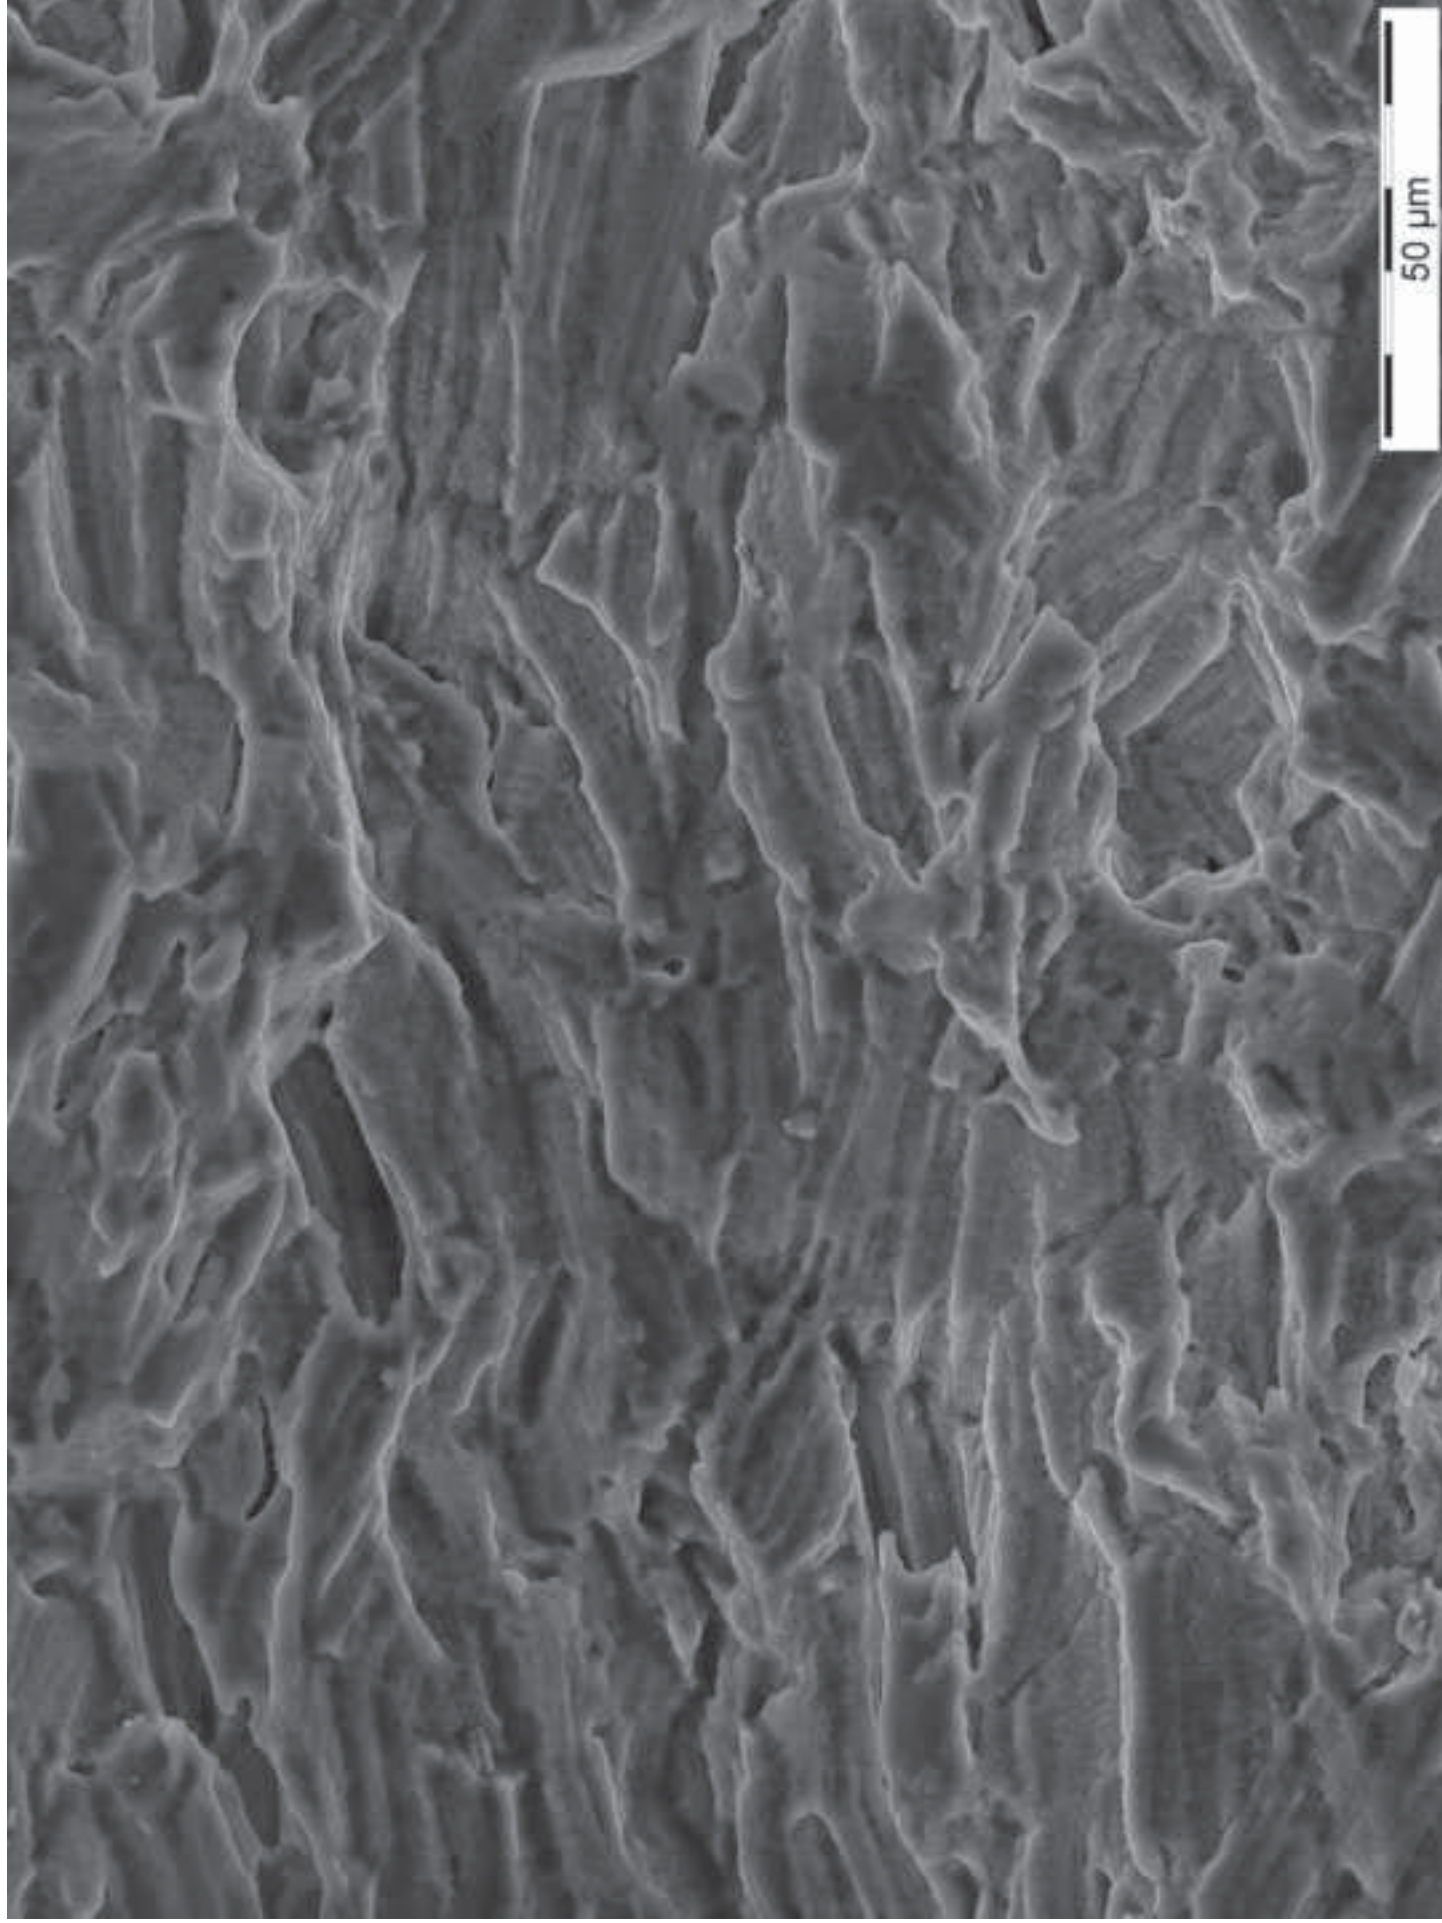
Figure 11
[Click here to download high resolution image](#)

The fracture surface of the SSRT tested PEO coated specimens had very similar features as that of the SSRT tested untreated specimens (in ASTM solution), and a representative fractograph of the PEO coated specimen is depicted in Figure 11. Even though the RA and apparent strain values were marginally higher, the fracture surface appearance was quite brittle, suggesting that the PEO treatment did not prevent the SCC of this parent alloy/weldment in ASTM D1384 solution even at this higher strain rate. It had already been demonstrated in a recent work that the PEO coatings do not influence the SCC behaviour of AZ61 wrought magnesium alloy in ASTM D 1384 solution [25]. It, however, remains to be seen as to how this parent alloy and the weldment with and without the PEO treatment behave in the constant load SCC tests at stress levels below the yield strength.

(d) crack in the HAZ close to the fusion boundary in the root region of the weldment (marked in dotted square in (b))
- Figure 11 Scanning electron fractograph of the SSRT tested (in ASTM solution) PEO coated parent alloy specimen
