**Pitting-induced hydrogen embrittlement of
magnesium-aluminium alloy**

In: Materials and Design (2012) Elsevier

In this study, the pitting susceptibility and its role on the hydrogen embrittlement behavior of AZ80 magnesium alloy were studied. Electrochemical and immersion tests suggest that AZ80 alloy undergoes severe pitting corrosion in chloride-containing solution. Slow strain rate testing of pre-exposed and continuously-exposed alloy in chloride-containing solution and in distilled water suggest that pitting corrosion facilitates hydrogen entry into the alloy and significantly deteriorates its mechanical properties. Cleavage facets were observed in the vicinity of the localized attacked region. Further, the values of the mechanical properties of the alloy which was pre-exposed to chloride-containing solution and then desiccated for a few hours were higher than those of the alloy tested immediately after pre-exposure to chloride-containing solution, which confirms the proposition that pitting corrosion induces hydrogen into the alloy and causes hydrogen embrittlement.

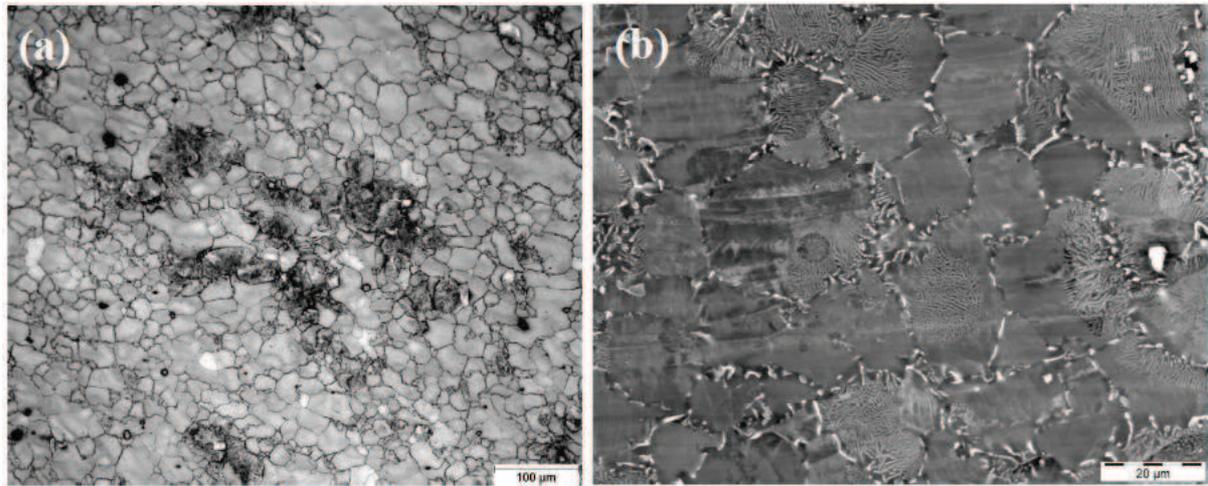
Fig. 1 Microstructures of AZ80 magnesium alloy: (a) optical micrograph shows the fine grains and clusters; and (b) a higher magnification SEM micrograph of the clusters reveal lamellar like structure of the particles.

Optical microstructure of AZ80 alloy showed fine grains and some random clusters of secondary phase particles (Fig. 1a). A higher magnification of the clusters revealed a lamellar structure of the particles (Fig. 1b). The grain boundaries were also

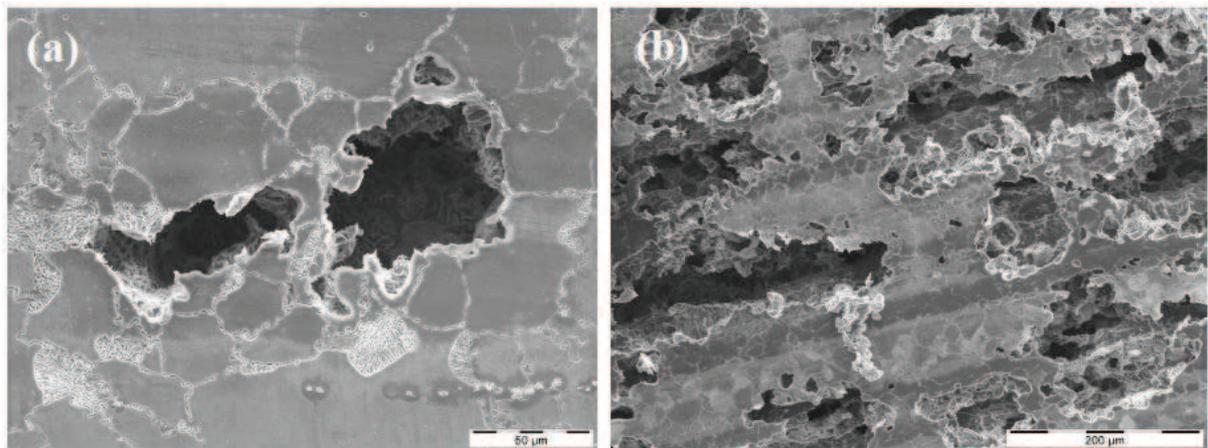
Fig. 2 SEM micrographs of AZ80 magnesium alloy after immersion in 0.5 wt.% NaCl solution: (a) 4 hours immersion shows large pits ; and (b) 24 hours immersion shows coalescence of pits forming trenches.

The SEM micrographs of the alloy after immersion in 0.5 wt.-% NaCl solution for two different durations are shown in Fig. 2. The alloy immersed for 4 hours showed pitting corrosion and also some attack along the grain boundaries (Fig. 2a). The pit size was similar to the grain size of the alloy, which suggests two possible mechanisms: (i) complete dissolution of grains, or (ii) continuous attack along the grain boundaries leading to the falling out of the grains. Although a few small pits were evident in the grains, the latter mechanism appears to be more likely in creating large pits since grain boundary attack was predominant. The grains containing lamellar structure of β -precipitates showed selective dissolution of only the α -phase leaving behind the stable network of β -precipitates. The degree of attack in the alloy increased significantly when the alloy was immersed for a longer period, i.e., 24 hours (Fig. 2b). The pits had coalesced along the extrusion direction, creating trenches.

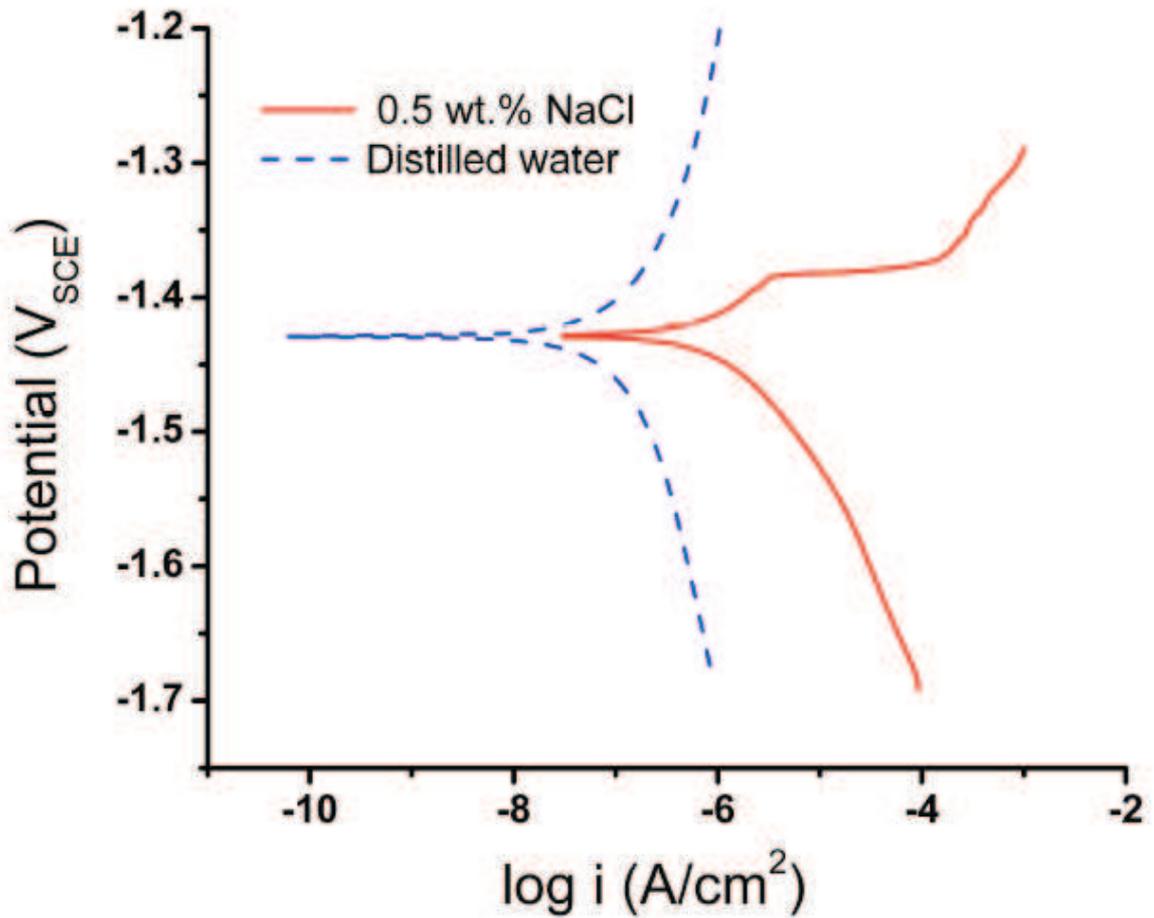
Fig. 3 Potentiodynamic polarisation of AZ80 magnesium alloy in 0.5 wt.% NaCl and in distilled water.

The polarization curve of the alloy obtained in 0.5 wt.-% NaCl solution is shown in Fig. 3. The anodic curve of the alloy showed a break-down potential just 50 mV above the corrosion potential (E_{corr}). Generally, an observation of a break-down potential in the anodic curve is related to passive-film breakdown/pitting corrosion of the alloy. In order to confirm this, AZ80 alloy was tested in distilled water. The alloy showed no break-down potential in distilled water (Fig. 3), thereby confirming that the breakdown potential was an indication of the alloy's susceptibility

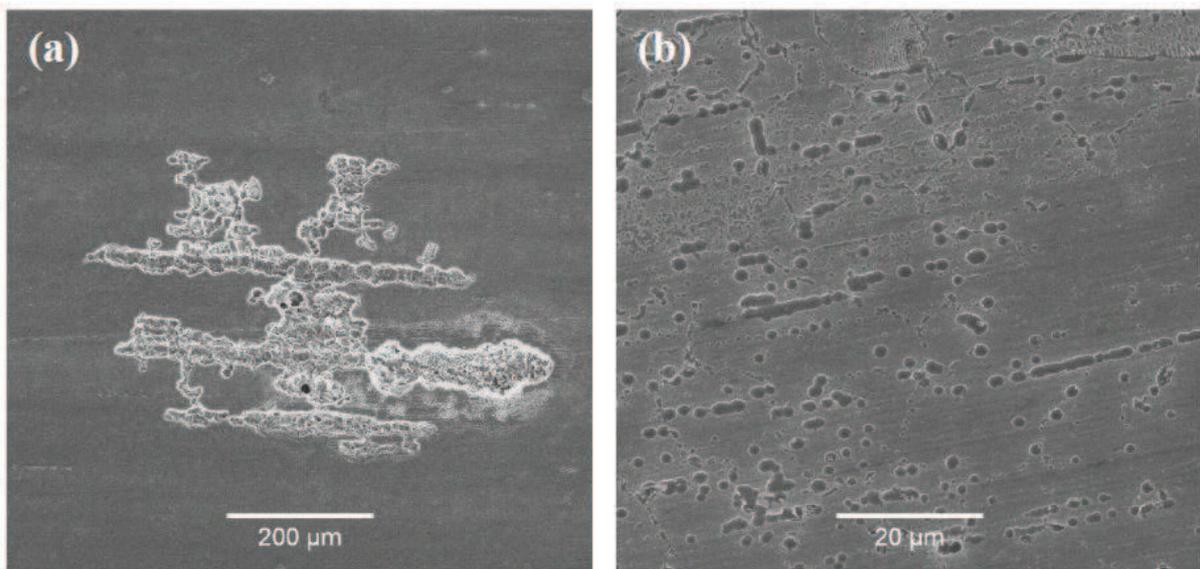
Fig. 4 Microstructures of AZ80 magnesium alloy after potentiodynamic polarization test in 0.5 wt.% NaCl solution: (a) large localized attack ; and (b) a large number of fine pits.

to pitting corrosion in chloride-containing environment. Further, the SEM micrographs of the sample after polarisation in 0.5 wt.% NaCl also showed large pits (Fig. 4a). A higher magnification of the corroded sample revealed a large number of small pits and coalescence of pits (Fig. 4b).

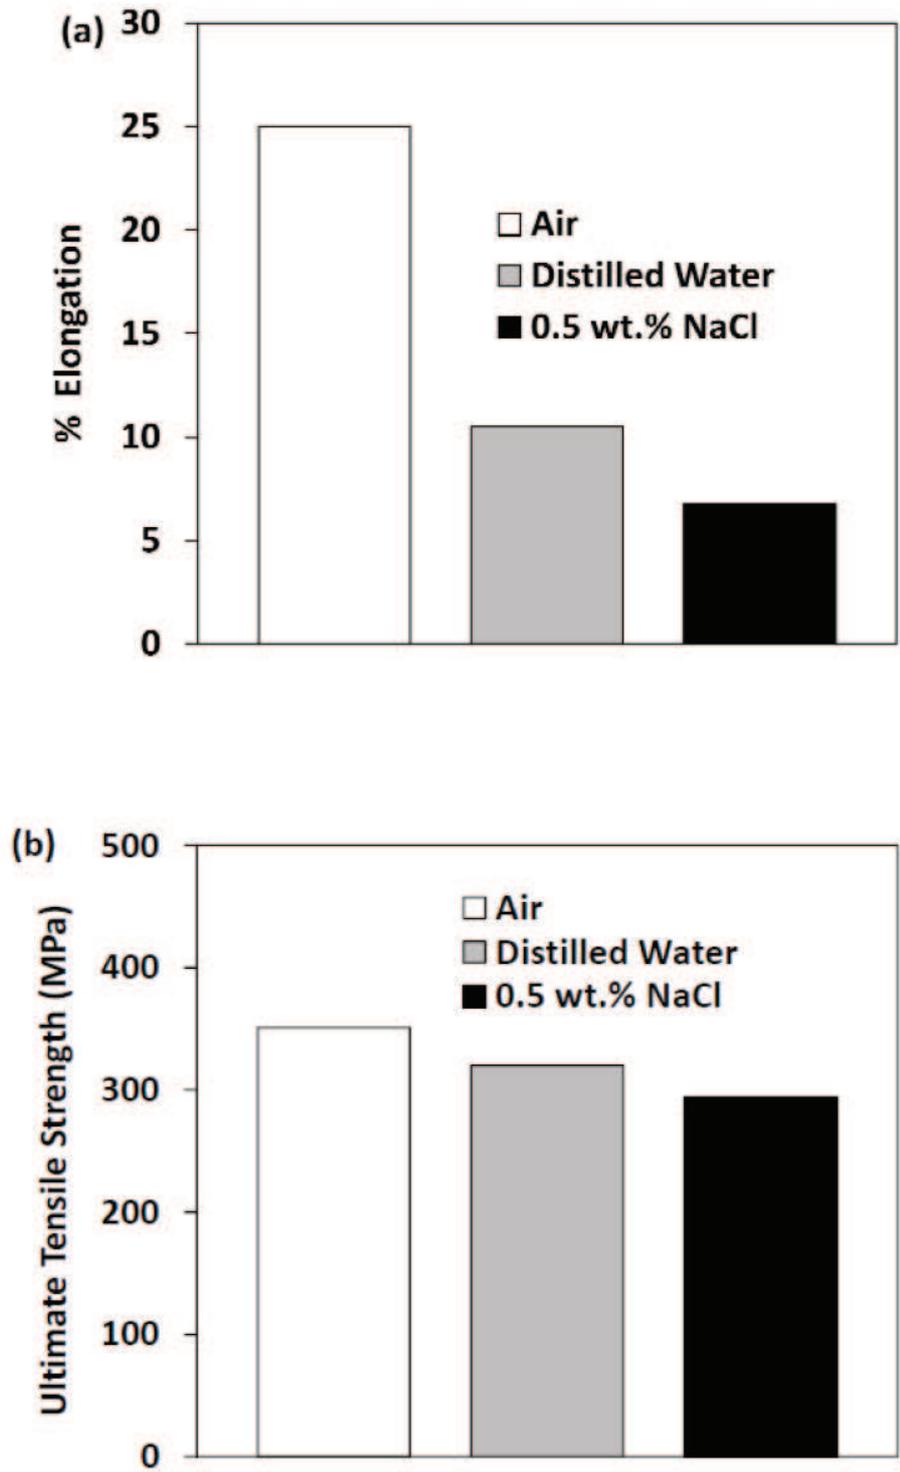
Fig. 5 SSRT data of AZ80 alloy exposed to different environments during the tests: (a) % Elongation and (b) Ultimate tensile strength.

The SSRT data of AZ80 alloy tested in different environments, i.e., in air, distilled water and in 0.5 wt.-% NaCl solution is shown in Fig. 5. The alloy exhibited a strain to failure, ϵ_f , of 25 % and an UTS of 350 MPa when tested in air. In the tests in distilled water, the alloy showed significantly lower mechanical properties: $\epsilon_f = 11$ % and UTS = 320 MPa. The mechanical properties further decreased in the presence of chloride (i.e., 0.5 wt.% NaCl): $\epsilon_f = 7$ % and UTS = 290 MPa.

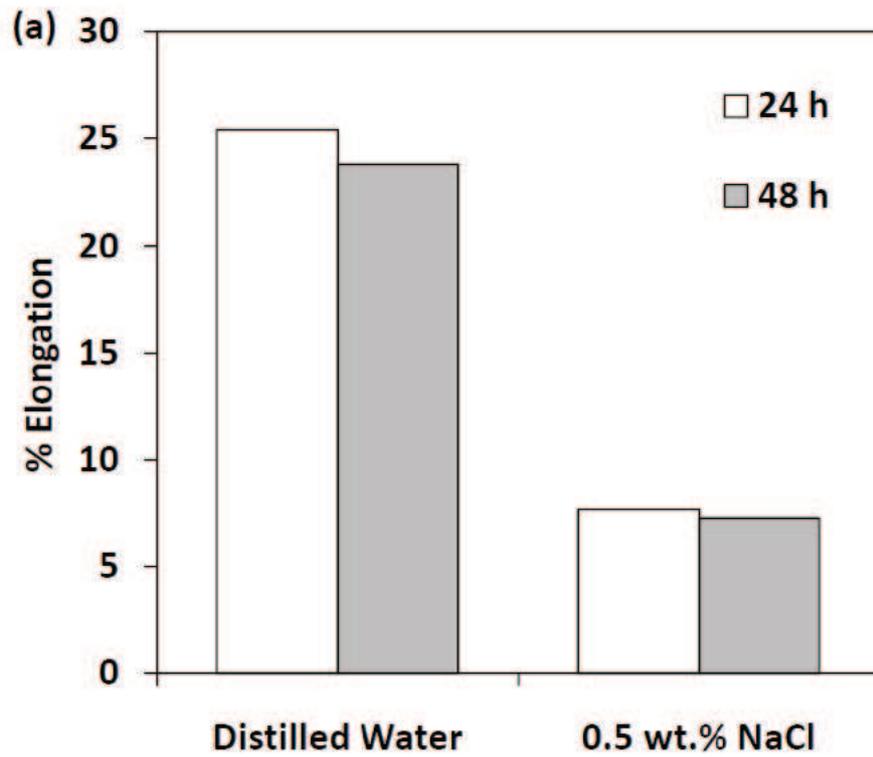
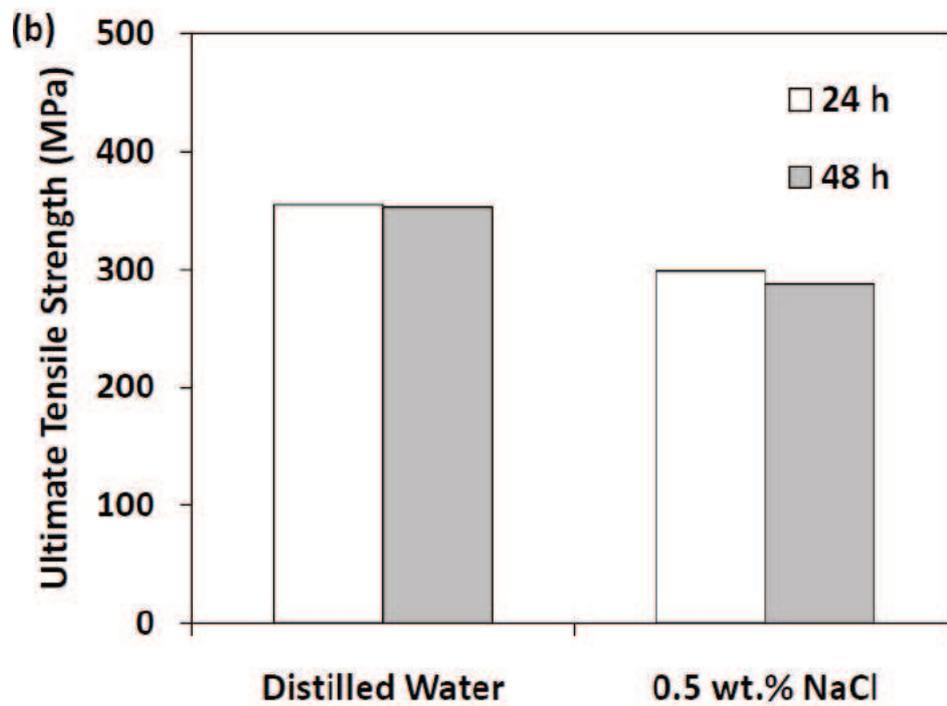
Fig. 6 SSRT data of AZ80 alloy pre-exposed to different environments for two different period of time: (a) % Elongation and (b) Ultimate tensile strength.

The SSRT data of AZ80 alloy tested in air after pre-exposure to distilled water and in 0.5 wt.-% NaCl for 24 hours period is shown in Fig. 6. The alloy pre-exposed to distilled water did not show any noticeable difference in the mechanical properties from that of the air tested samples; accordingly, the pre-exposed alloy exhibited: $\epsilon_f = 25$ % and UTS = 355 MPa. However, the alloy pre-exposure to 0.5wt.% NaCl solution showed a drastic loss in the mechanical properties. Thus, the alloy pre-exposed to 0.5wt.% NaCl solution exhibited: $\epsilon_f = 8$ % and UTS = 300 MPa. In order to see whether there was any influence of increasing pre-exposure period, the samples were pre-exposed to distilled water and 0.5wt.% NaCl solution for 48 hours. The alloy pre-exposed to distilled water did not show any significant change in the mechanical properties, i.e. $\epsilon_f = 24$ % and UTS = 350 MPa, as compared to the 24 hours pre-exposed alloy. However, the mechanical properties of the alloy decreased marginally when pre-exposed to 0.5wt.% NaCl solution for 48 hours as compared to that of the

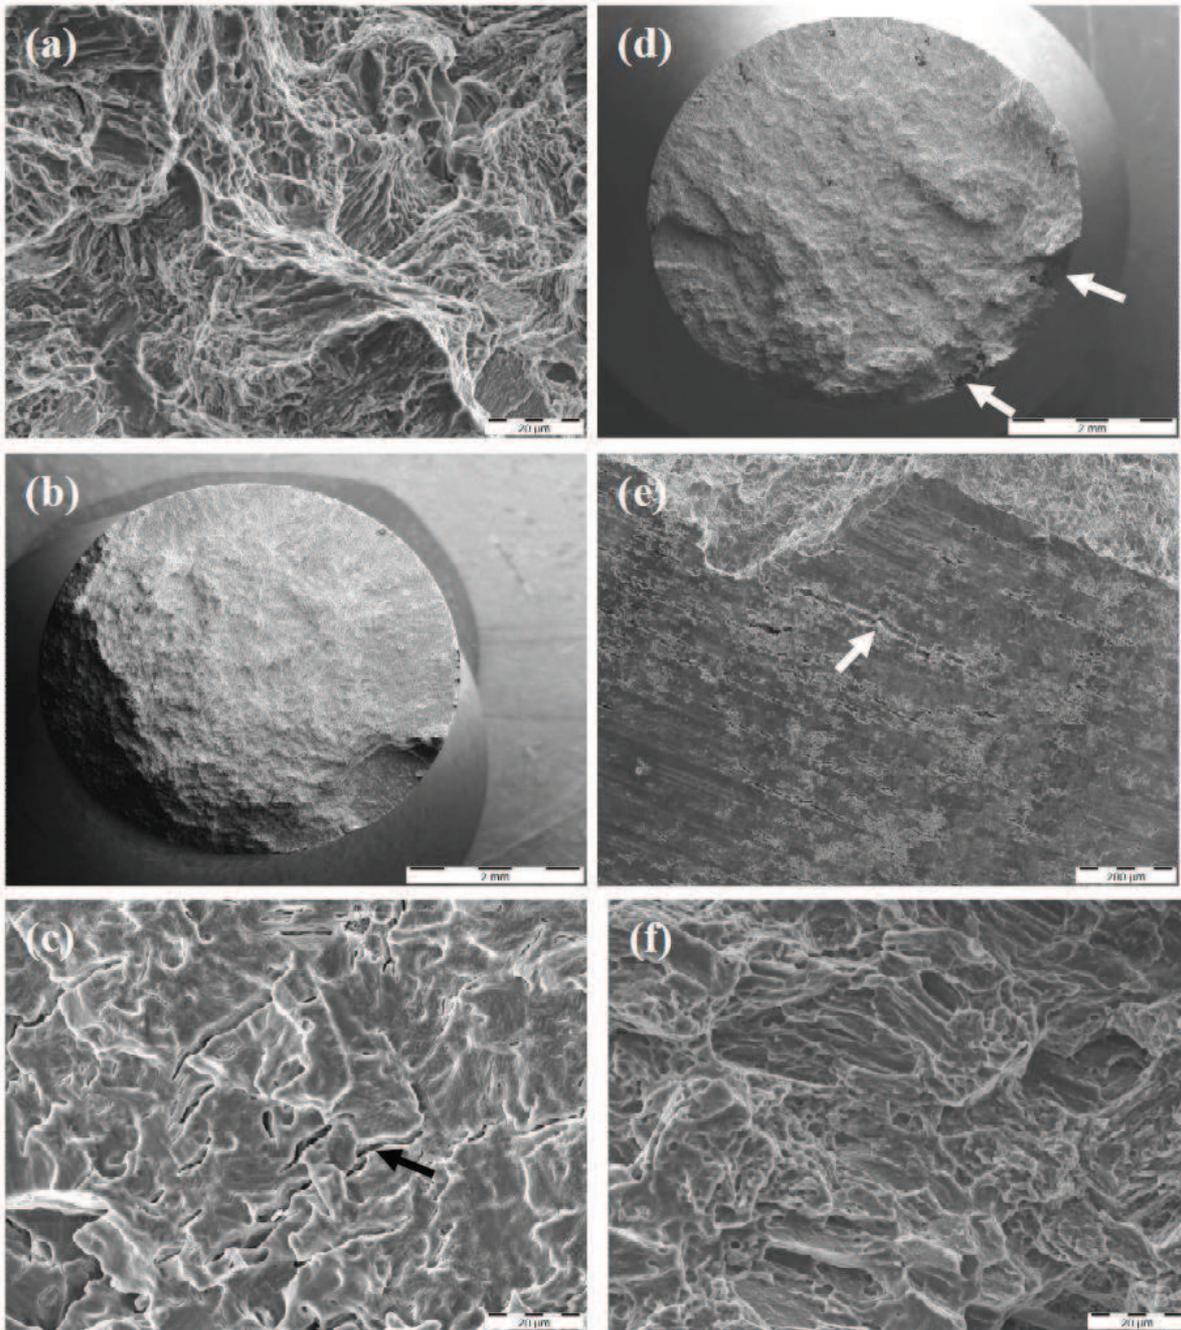
Fig. 7 Fracture surfaces of AZ80 alloy: (a) air – ductile fracture; (b) and (c) distilled water – (b) brittle fracture and (c) transgranular cracking and secondary cracks; (d), (e) and (f) 0.5wt.% NaCl solution - (d) brittle fracture and localized attack along the edge, (e) surface of tensile sample showing high localized attack, and (f) exhibits transgranular cleavage and a few fine dimples.

Fig. 7 shows representative fractographs of the SSRT samples tested in air, distilled water and in 0.5wt.% NaCl solution. As expected, the alloy tested in air showed typical ductile fracture features (Fig. 7a). In contrast, the alloy tested in distilled water showed a brittle failure (Fig. 7b). A higher magnification of the fracture surface revealed predominantly transgranular cracking with some secondary cracks (Fig. 7c). The alloy tested in 0.5 wt.% NaCl solution showed a different mode of failure. Noticeably, the edge of the fracture surface exhibited significant pitting corrosion (Fig. 7d). The circumference of the failed tensile sample revealed localized corrosion attack (Fig. 7e) similar to that of the flat samples immersed in 0.5wt.% NaCl solution for 24 hours (Fig. 2b). The fracture surface revealed a mixed-mode of failure, i.e. brittle features and a few fine dimples (Fig. 7f).

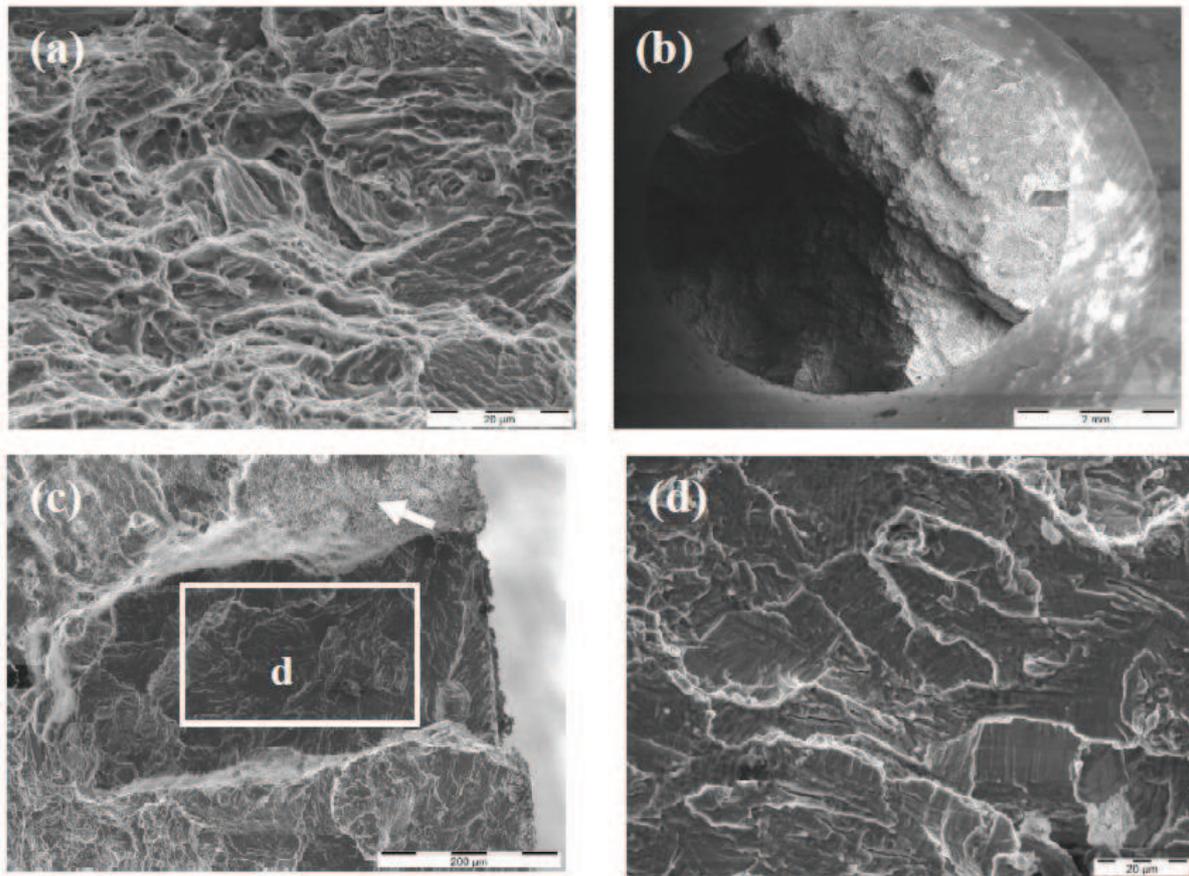
Fig. 8 Fracture surface of pre-exposed AZ80 alloy for 48h: (a) distilled water – ductile rupture; (b), (c) and (d) 0.5 wt.% NaCl solution – (b) overall fracture surface, (c) localized attack along the edge of the sample (arrow), and (d) typical cleavage facets.

The fractographs of the alloy pre-exposed to distilled water and to 0.5 wt.% NaCl solution for 48 hours are shown in Fig. 8. Similar to the air tested sample (Fig. 7a) the fracture surface of the alloy which had been pre-exposed to distilled water showed typical ductile fracture features (Fig. 8a). However, the fracture surface of the alloy pre-exposed to 0.5 wt.% NaCl solution showed two distinct regions, i.e. localized corrosion attack at the edge of the fracture surface and some brittle feature (Fig. 8b). Typical cleavage facets were observed in the vicinity of localized corrosion region (Fig. 8c,d).

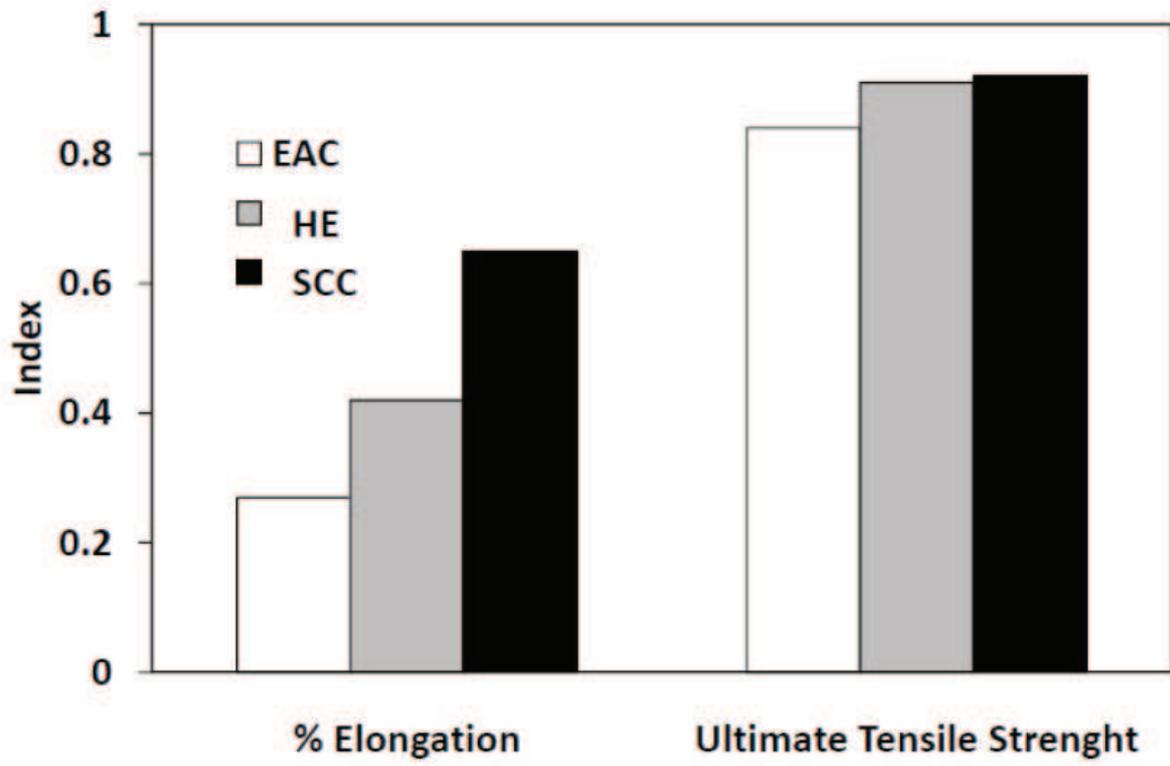
Fig. 9 Environmental assisted cracking, hydrogen embrittlement and stress corrosion cracking susceptibility indices for AZ80 alloy.

To individually quantify the susceptibility of the alloy to EAC, HE and SCC (chloride-induced), their susceptibility indices were calculated as follows: I_{EAC} = mechanical properties in chloride-containing solution/ mechanical properties in air; I_{HE} = mechanical properties in distilled water/mechanical properties in air; I_{SCC} = mechanical properties in chloride-containing solution/mechanical properties in distilled water. A low index (EAC/HE/SCC) suggests high susceptibility of the alloy to a particular environment, and when the index approaches unity it means that the alloy is highly resistant to the particular environment. The calculated indices presented in Fig. 9 suggest that both chloride and hydrogen played a role in the EAC susceptibility of the alloy and that in fact they had a synergetic effect.
