**Failure of Magnesium Sheets Under Monotonic Loading:  
3D Examination of Fracture Mode and Mechanisms**

# FAILURE OF MAGNESIUM SHEETS UNDER MONOTONIC LOADING: 3D EXAMINATION OF FRACTURE MODE AND MECHANISMS

**Abstract.** Damage evolution in a commercial magnesium sheet alloy (Mg-3Al-1Zn-0.3Mn) at room temperature is investigated. Kahn tear tests were performed to characterize the crack extension behaviour. Scanning electron microscopy of the fracture surfaces revealed flat inclined areas and the absence of cracked particles and dimples. Post-mortem synchrotron tomography of a stopped crack was used to further identify the predominant damage mechanism in the specimen's ligament. Nucleation of submicrometre-voids, a micro-void sheeting mechanism and the absence of classical void growth could be identified.

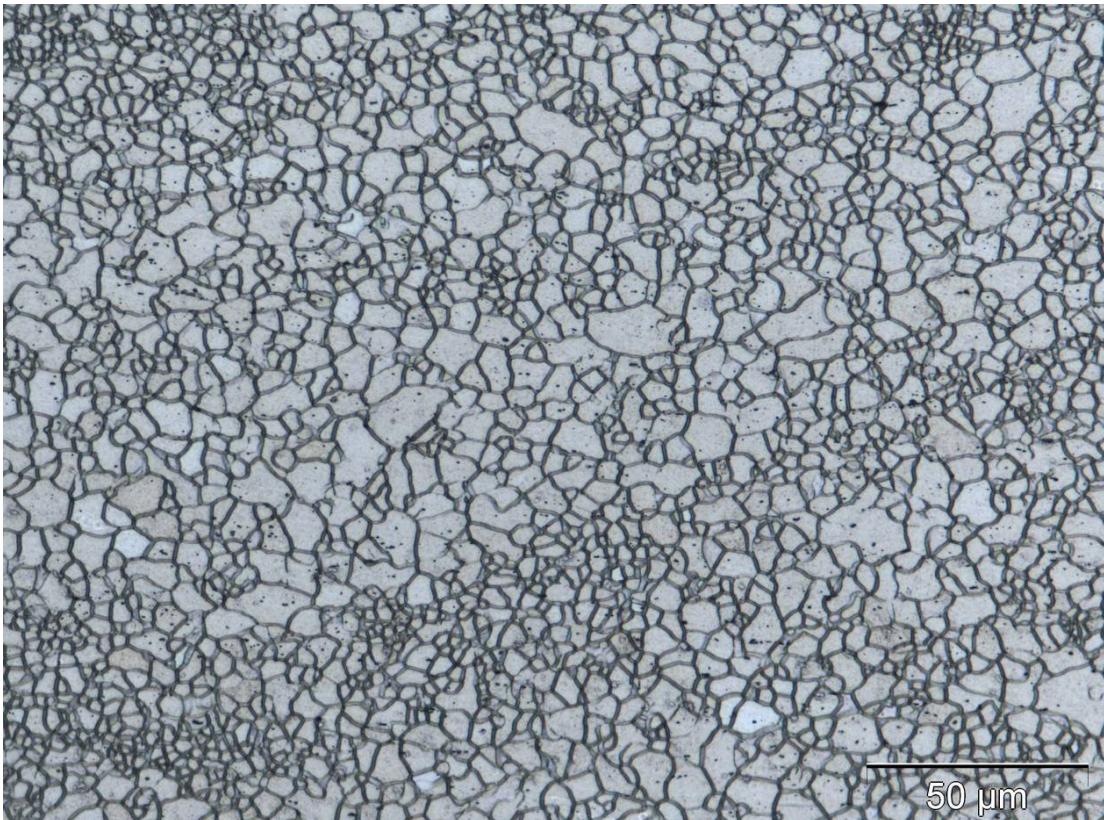
Figure 1: Optical micrograph of a longitudinal section (RD-ND plane) after etching of the AZ31-sheet showing a recrystallised microstructure and precipitates inside the grains.

**2. Microstructure and mechanical tests.** The microstructure of the investigated material can be inspected from Figure 1. It shows a fully recrystallised microstructure observed in the plane span by the rolling direction (RD) and the short transverse or normal direction (ND), (RD-ND)-plane. Regions with smaller grains are present in shear bands which developed during rolling. However, the grain size distribution can still be regarded as being homogenous. The average grain size measured in two perpendicular planes collinear with the normal direction (ND) is 5 microns. Precipitates appear as black dots in the figure. Their size appears unrealistically large, as the etchant used caused heavy corrosion.

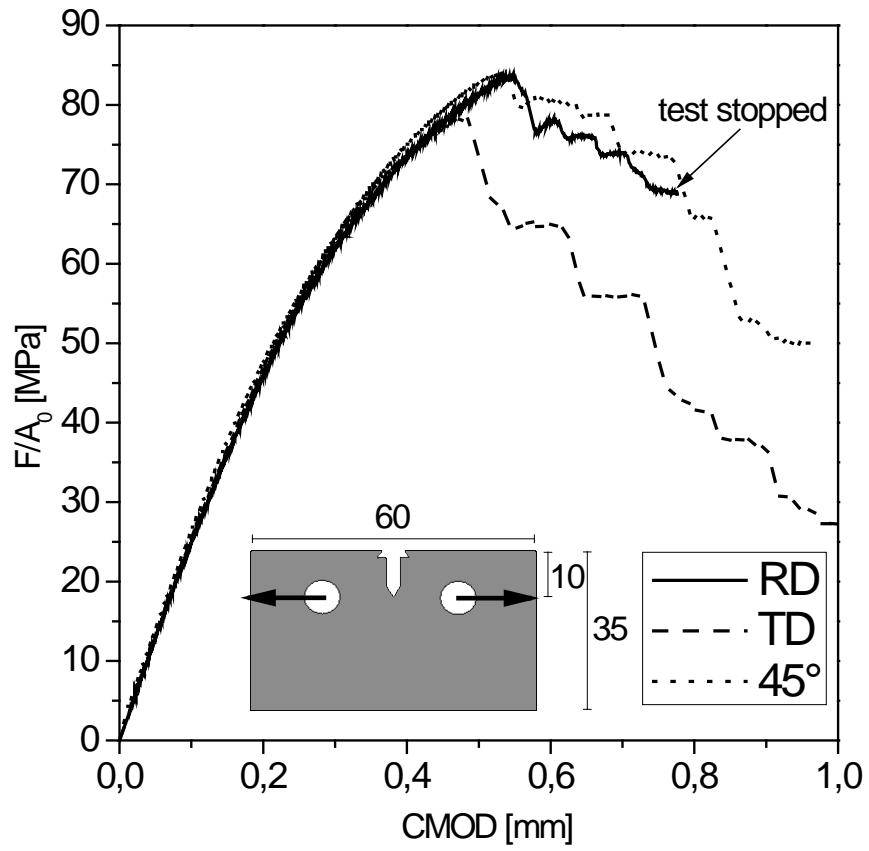
Figure 2: Normalised force-CMOD behaviour of the tested samples. Specimen loaded in RD-orientation was further investigated. Measures in mm.

Nine Kahn specimens (dimensions: 35 mm x 60 mm x 1.0 mm) were machined along three different orientations, namely RD (rolling direction is the main loading direction), TD (transverse direction) and  $45^\circ$  with the rolling direction. Electro-discharge machining (EDM) was used to avoid the mechanical damage associated with conventional machining. The tensile load (displacement control) was applied with a rate of 0.003 mm/s. Cracks were grown to a minimum length of 4 mm in the Kahn tear tests. The tests were stopped before final failure of the coupon. The recorded force-crack mouth opening displacement (CMOD) records of one representative specimen per orientation are shown in Figure 2. The recorded force signal was normalised by the ligament's initial cross-section,  $A_0=25 \text{ mm}^2$  to allow for comparison with thicker specimens and other materials. All specimens show a sudden decrease of the stress once a crack starts to extend. This point is reached earlier in case of the TD-orientation sample and later in case of RD- and  $45^\circ$ -oriented specimens. Small differences in terms of the stress level prior to crack extension between specimens of different orientation are evident, which is a consequence of the plastic anisotropy (Steglich et al. 2012). The unsteady decrease of the external force indicates that the crack extends in an unstable manner. Fractography using a scanning electron microscope revealed a

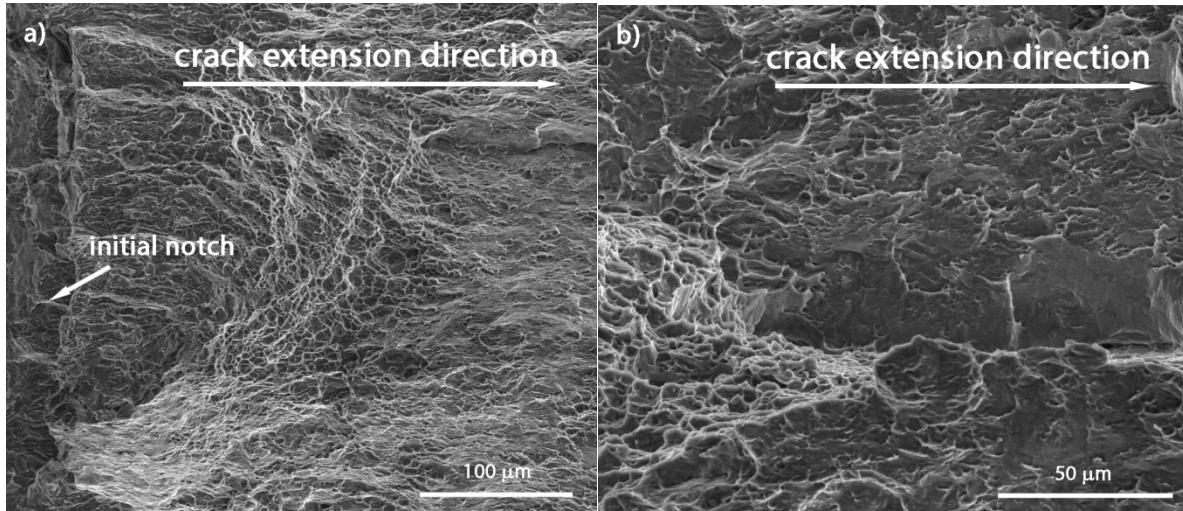
Figure 3: SEM micrographs showing the fracture surface ahead of the initial notch tip with small dimples (a) and in the flat-to-slat transition region showing flat surfaces with micro-dimples (b).

macroscopically rough fracture surface. Microscopically, two main features can be observed: A very small amount of ductile crack extension in a dimple-dominated triangle region ahead of the initial crack tip (Figure 3a), and the remaining large region showing flat surfaces (Figure 3b) of a size similar to the grain size. While the triangular section is oriented perpendicular to the main loading direction, the major part of the fracture surface is irregularly tilted by  $45^\circ$  against the sheet's normal direction. As dimples are hardly visible on that part of the fracture surface, it seems that failure is not based on void growth and coalescence here. Thus it is not a typical ductile failure mechanism. The fracture surface bears similar features like the one described recently (Liang et al. 2013), where "quasicleavage fracture characteristics" are reported for a extruded Mg-alloy of similar chemical composition.

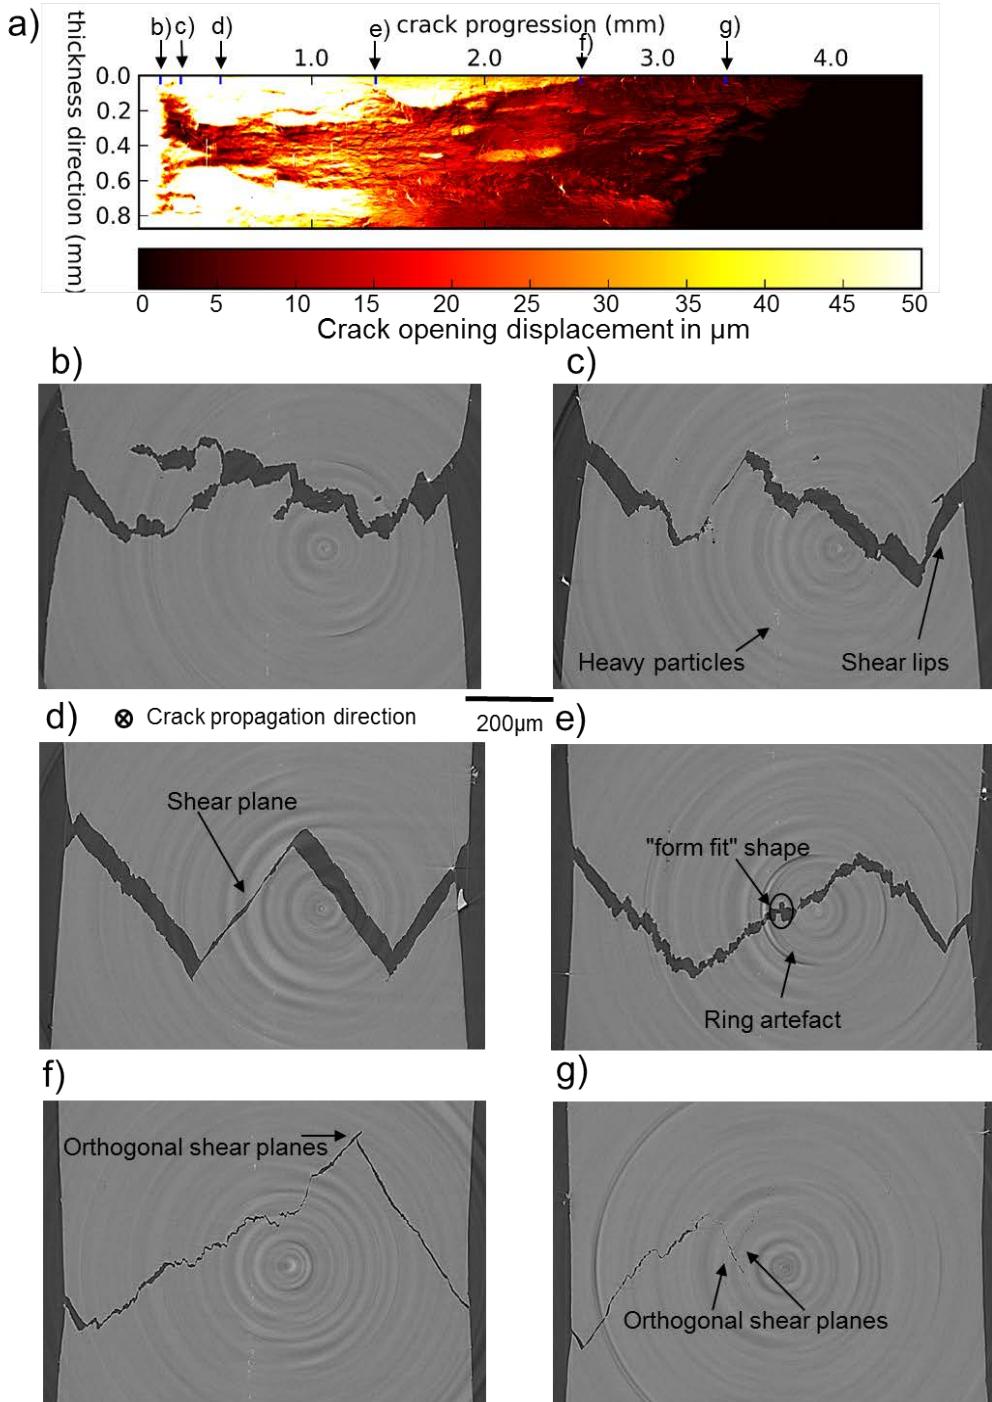
Figure 4: Tomography data of the stopped crack in terms of local crack tip opening displacement (CTOD) (a) and in terms of 2D sections normal to the crack propagation direction at different distances from the notch root (b)-(g).

Figure 4 shows tomography data of the stopped crack in terms of local crack opening displacement (COD) (Figure 4a) and in terms of 2D sections normal to the crack propagation direction at different distances from the notch root (Figure 4b-g). Figure 4a gives an overview over the crack from the notch root to the crack tip. The locations where the 2D sections were taken are indicated. It can be seen that the crack tip is neither straight nor tunnelling but inclined with respect to the specimen surface. The bright regions in the local CTOD map represent the regions near the surface where shear lips separate from each other due to non-symmetric (mode III) opening of the crack. In the middle of the crack at 1 mm from the notch root some uneven local crack tip opening can be seen that is a hint for the surface roughness in this area.

Figure 4b shows a 2D section at the notch root. The curved sides of the specimen result from necking of the ligament. Some opened crack regions can be seen as well as narrow regions and crack bifurcation. However, in contrast to other engineering alloys such as aluminium alloys, no second phase particles are discernible in this AZ31 alloy that could act as void nucleation sites. Around the crack hardly any micrometric voids are visible. Figure 4c shows a region 0.1 mm away from the notch root. Again only very few voids can be seen around the crack (black spots). This is astonishing as the stress triaxiality is expected to be at a maximum in the crack initiation region and a high triaxiality is known to trigger void growth (Bron and Besson 2006). The opened regions of the crack seem to be less caused by void growth but by the crack surface opening, because the opposite surfaces would still fit together. Some white features can be seen at the mid-thickness: Heavy particles, which are however not cracked. Figure 4d is taken at ~0.4 mm from the notch root. No voids are seen around the crack that has a zig-zag shape and a very smooth fracture surface. Again, the damage process does not seem to be consistent with a classical ductile damage process that includes pre-existing voids or void nucleation at brittle particles, their subsequent growth

and coalescence. Despite the expected high levels of stress triaxiality no micrometric voids are seen here either. The damage process consists of strain localisation in very narrow inclined bands followed by sudden failure at sub-micrometre scale. Figure 4e shows the crack at 1.5 mm from the notch root. Near the surface smooth areas corresponding to shear lips are present whereas the centre of the crack is rough. There still seems to be little void growth but the rough surface points to a different fracture mechanism compared to the shear lips. Possibly the increased level of stress triaxiality in the centre of the specimen favours a failure of grain boundaries but supplementary experimental assessments would be necessary to confirm this point. Figure 4f and g represent cross-sections at 2.5 mm and 3.5 mm from the notch root, respectively. Again the competition between smooth shear lip failure and rough surface failure can be inspected. In addition, the “overshoot” of two orthogonal damage planes can be seen in the two images. This seems to indicate that orthogonal strain bands are active during tearing that lead to cracking of the material. In Figure 4g (corresponds to the stopped crack tip) there are hardly any voids ahead of the crack visible. The crack extension mechanism seems to be governed by simultaneous nucleation and coalescence of sub-micrometre voids in the strain bands (see also fractography in Figure 3). Void growth cannot be observed.
