Effect of unequal levels of deformation and fragmentation on the electrochemical response of friction stir welded AA2024-T3 alloy.

In: Electrochimica Acta. Vol. 313 (2019) 271 – 281.

**Effect of Unequal Levels of Deformation and Fragmentation on the
Electrochemical Response of Friction Stir Welded AA2024-T3 alloy**

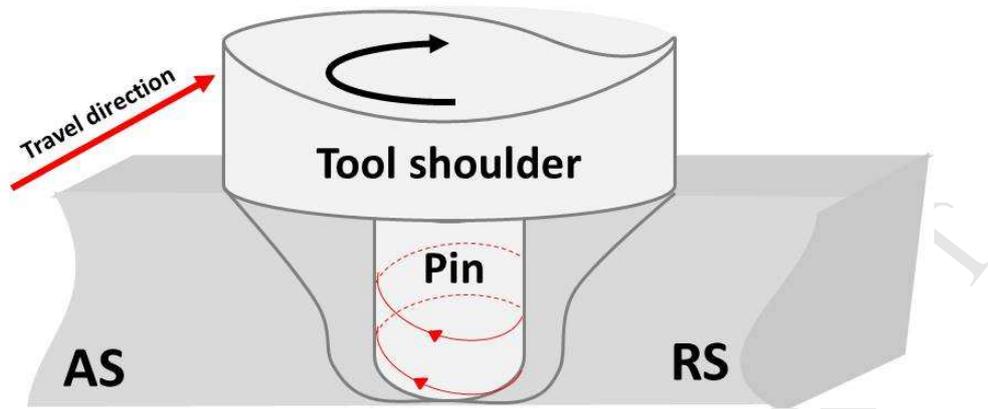
Figure. 1. Schematic representation of the FSW process.

Friction stir welded plates, 2 mm, of AA 2024-T3 alloy (Mg 1.6, Cu 4.8, Fe 0.22, Mn 0.64, Si 0.19, Zn 0.08, P 0.03, S 0.02, Ca 0.04, Ti 0.05, Cr 0.04, Al Bal (wt %)) were provided by a Brazilian company. The welding procedure is proprietary and employs a ratio between the tool speed rotation (rpm) and the travel speed (mm/min) of 2.43, which lies within the limits of 1.39 and 6.4 used by Jariyaboon et al. [4] in their investigation of the influence of the welding parameters on the corrosion behaviour of friction stir welded AA2024-T3 alloy. A schematic representation of the FSW process showing both the rotation and travel direction of the welding tool is presented in Figure 1.

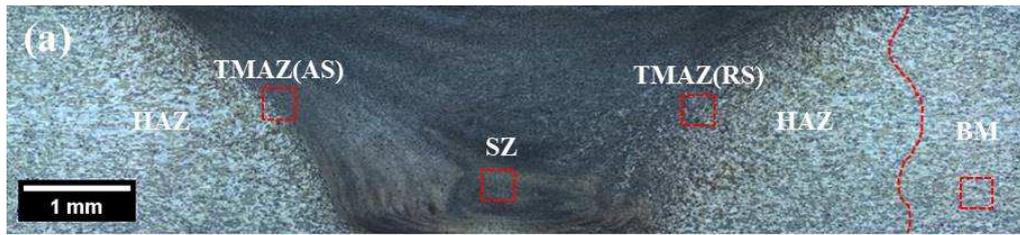
Figure. 2. Cross section of the friction stir welded joint. The dashed red boxes indicate the regions where EBSD maps were acquired.

Figure 2 shows the cross-section of the whole welded joint where the SZ and the TMAZ at the AS and RS are identified. In order to explore the variation of crystallographic orientations and mesotexture changes due to the FSW process and their possible correlation with corrosion activity, EBSD measurements were performed in the areas identified by red boxes in the Figure, and their results are discussed in detail in the following paragraphs. The EBSD of the base material was recorded 10 mm away from the SZ towards the RS.

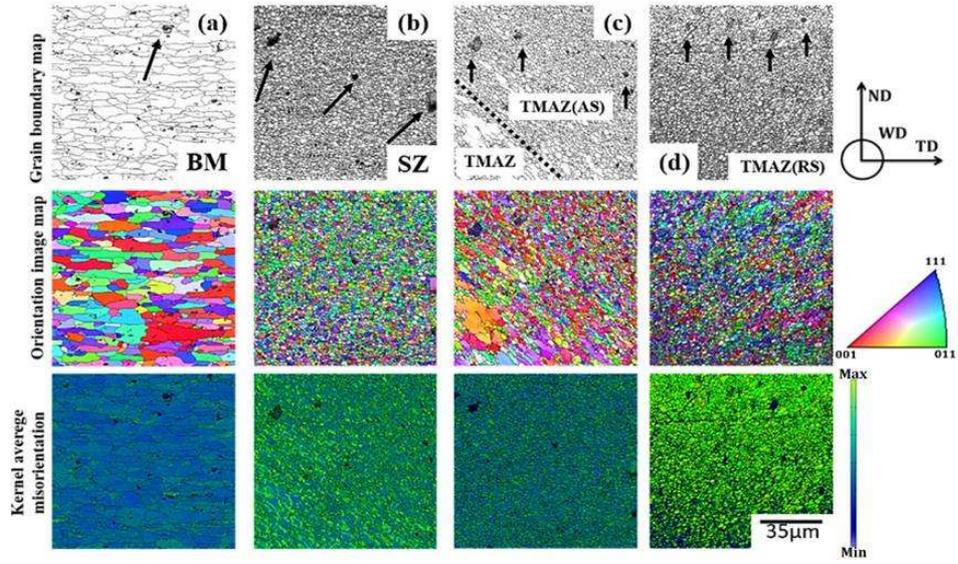
Figure. 3. EBSD analysis, grain boundary, orientation image, and Kernel average distribution maps of (a) base material, (b) stirred zone, (c) TMAZ at the advancing side, (d) TMAZ at the retreating side.

Grain boundaries, orientation images, and Kernel average misorientation maps of each of the regions highlighted in Figure 2 are presented in Figure 3. The average size of α -Al grains in the parent microstructure of the base AA2024 (Figure 3(a)) was estimated to be about 7.5 μm . The microstructure is characterized by coarse grains with a large number of high angle boundaries. Also, some precipitates such as CuAl_2 and CuAl_2Mg were found in the grains and at the grains boundaries. Ultrafine equiaxed grains (smaller than 1 μm) were observed in the stir zone (Figure 3(b)). The severe plastic deformation during FSW with the associated high temperature enhanced dynamic recrystallization and grain refinement in this zone [23,24]. Low level of Kernel average misorientation values in the corresponding map also indicates the low level of accumulated dislocations due to the occurrence of dynamic recrystallization.

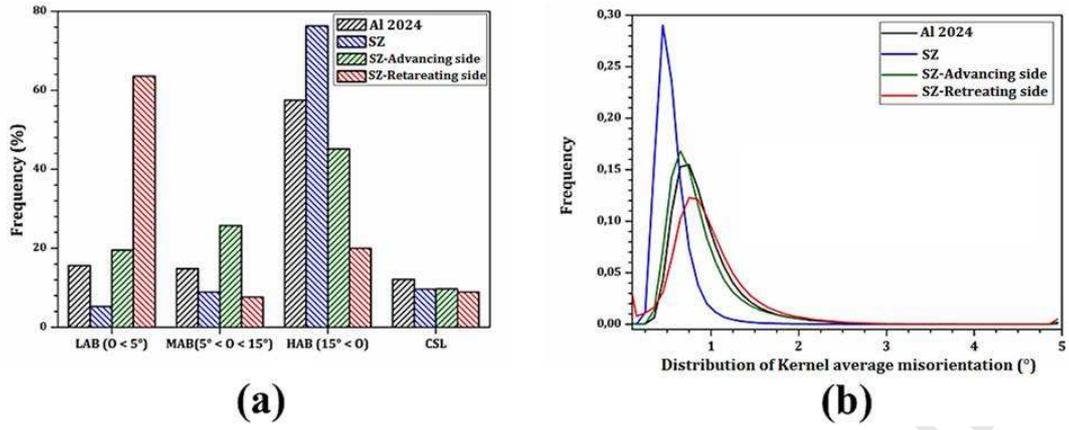
Figure. 4. (a) Boundary distribution and (b) variation of Kernel average misorientation of the different regions.

To investigate the mesotexture changes in distinct regions, Figure 4 shows the variation of boundary types and Kernel average misorientation (KAM). Grain boundaries are generally divided into high angle boundaries (HABs) at which point-to-point misorientation is greater than 15° and moderate angle boundaries (MABs) or subgrains ($5^\circ < \theta < 15^\circ$). Deformed grains are characterized by misorientation of less than 5° . As mentioned earlier, the intense plastic deformation at a higher temperature in the SZ formed a region with recrystallized ultrafine grain. Accordingly, the high fraction of HABs with a low number of MABs and deformed grains in the SZ indicate the development of non-deformed recrystallized grains with low stored energy. The same can be said of the TMAZ for the AS, howbeit, to a lower degree compared with the SZ. In contrast, a high number of deformed grains were identified in the TMAZ of the RS. This microstructure corresponds to a heavily distorted structure resulting from the material plastic flow during welding in the absence of dynamic recrystallization and recovery. In other words, plastic deformation in this region produced some crystallographic defects at the grain interior and at the grain boundaries which increased the stored energy and might influence its corrosion susceptibility. Figure 4 also shows that the variation of coincidence site lattice (CLS, or special boundaries) was negligible in all the zones.

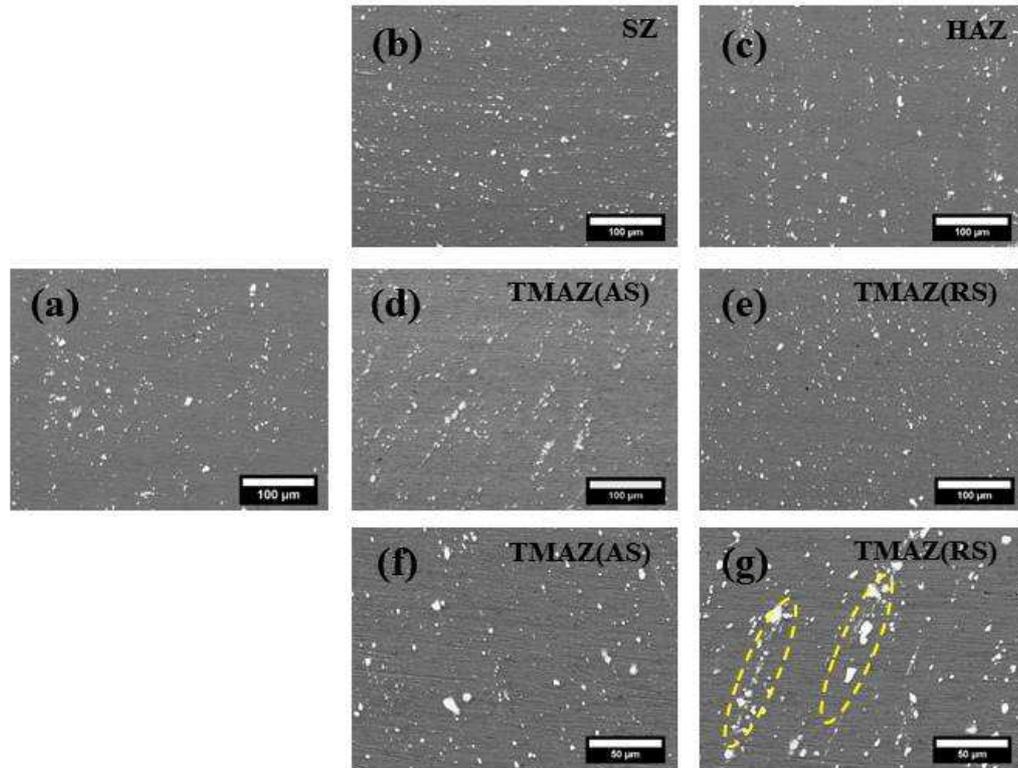
Figure. 5. SEM images showing the distribution and clustering of coarse intermetallic particles of the AA2024 alloy in the BM (a) and in the friction stir weldment: SZ (b), HAZ (c), TMAZ(AS) (d) and (f) and TMAZ(RS) (e) and (g).

Figure 5 shows SEM images of the distribution and degree of fragmentation (as evidenced by the particle sizes) in the different zones of the weld, as a reference a micrograph of the BM far from the weld zone was also added (Figure 5(a)). Because the deformation is higher in the TMAZ(AS) (Figures 5(d) and (f)) and SZ (Figure 5b)), the coarse intermetallics (IMCs) in these zones are more fragmented and more evenly distributed in these regions compared with the TMAZ(RS) (Figures 5(e) and (g)). In the RS side of the weld, the lower degree of deformation and the flow of the plasticized material results in less fragmentation and increased clustering of the coarse IMCs in the direction of tool motion (Figures 5 (e) and (g)). Comparing the TMAZ(AS) and the TMAZ(RS) in Figures 5 (f) and 5 (g), it can be observed that in addition to the clustering and lower degree of fragmentation of the coarse IMC particles, there were, to a larger extent, particle-free regions in the vicinities of the coarse particles in the RS compared with the AS. These unequal degrees of fragmentation and clustering influence the extent to which these regions are susceptible to corrosion as will be discussed in the following. Concerning the HAZ (Figure 5(c)), as expected, IMC distribution is very similar to that exhibited by the BM (Figure 5(a)), confirming that this feature is not affected by the FSW process.

except for the Fe and Mn-containing phases which are usually very stable [30]. Nonetheless, Cu-rich precipitates are still present in the zones of the weld, as shown in Figure 5, and these are predominantly the anodic S-phase since this phase makes up for more than 60% of the coarse particles in the AA2024 alloy [29]. Thus, the heterogeneous clustering of these particles can significantly influence the corrosion behaviour of the zones.

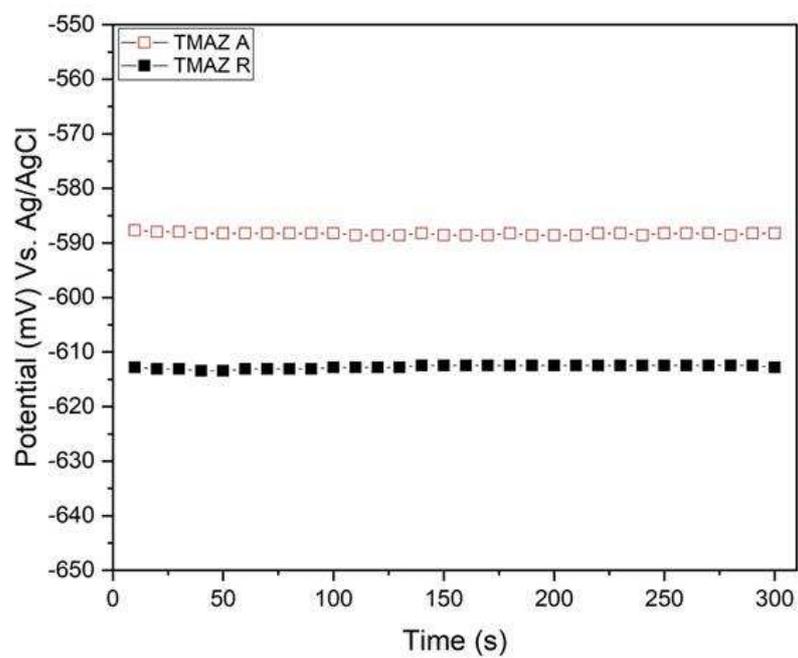
Figure. 8. OCP after 24h of immersion in 0.1M Na₂SO₄ + 1mM NaCl, for the thermomechanically affected zone (TMAZ), in advancing (A) and retreating (R) sides.

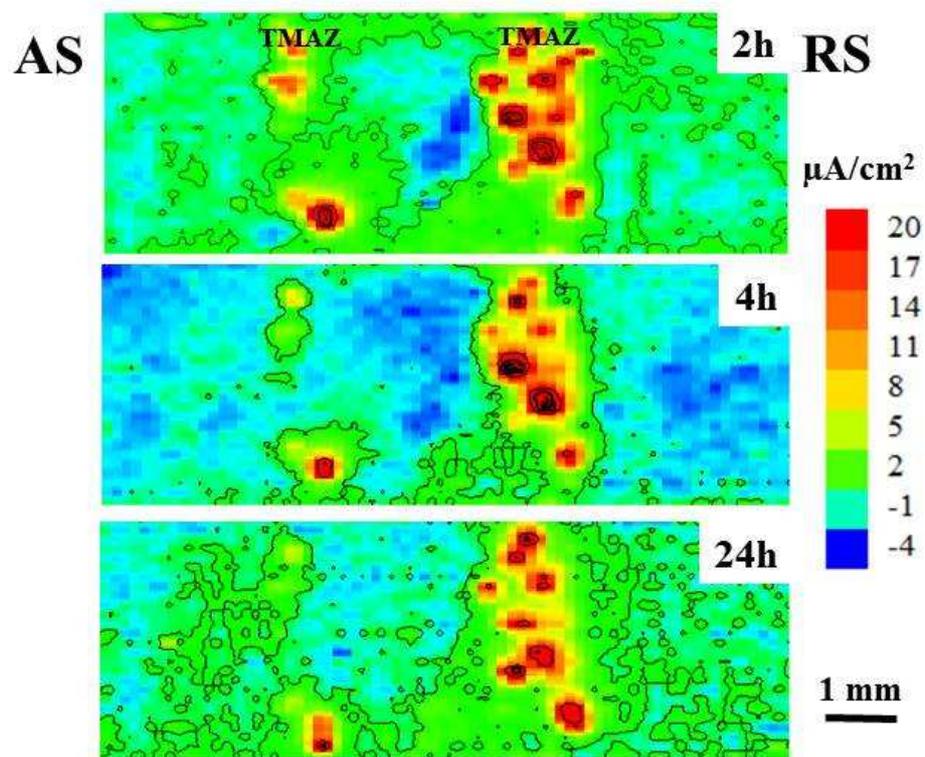
Figure. 10. SVET maps of the surface of the friction stir welded AA2024-T3 alloy showing the evolution of corrosion during immersion test in 5 mM NaCl solution.

Figures 10-11 show the SVET results for the entire surface of the weldment. In the SVET maps, blue colours represent cathodic sites, whereas red/orange regions characterize the zones with stronger anodic activity. During the early hours of the SVET test, pronounced anodic activities were observed on both TMAZ regions; but the activities were higher in the TMAZ(RS), and the number of SLC sites were also higher in this region compared with the TMAZ(AS). Except for a few more sites which developed during the test, the trend was the same throughout the test. SEM images of the different regions of the surface after the test (Figure 11) confirm the formation of SLC in the regions that showed high anodic activities on the SVET map. A typical feature of SLC in aluminium alloys is the presence of corrosion rings around the SLC sites, and this is evident in Figures 11(b) and 11(d) which correspond to the regions of high anodic activities on the SVET maps. The current density values are high in these regions because of the prevalent ionic currents resulting from the stable pitting activities. The stable pitting activities, in this case, are associated with galvanic interactions between coupled intermetallic particles and the matrix, and this result in deeply penetrating intergranular attack. On the contrary, regions without corrosion rings (Figure 11(c)) presented low current density values because stable pitting did not occur in such regions. The prevalent features in such regions were the formation of cavities and trenches around coarse intermetallic particles, and these did not involve high ionic currents to be detected by SVET. These features are associated with the dark spots in the SEM images. As clearly shown, the regions with corrosion rings were present on the TMAZ of both sides. Thus, certain areas of the TMAZ(AS) were also susceptible to SLC. However, the most anodic region in the weldment is clearly the TMAZ(RS).

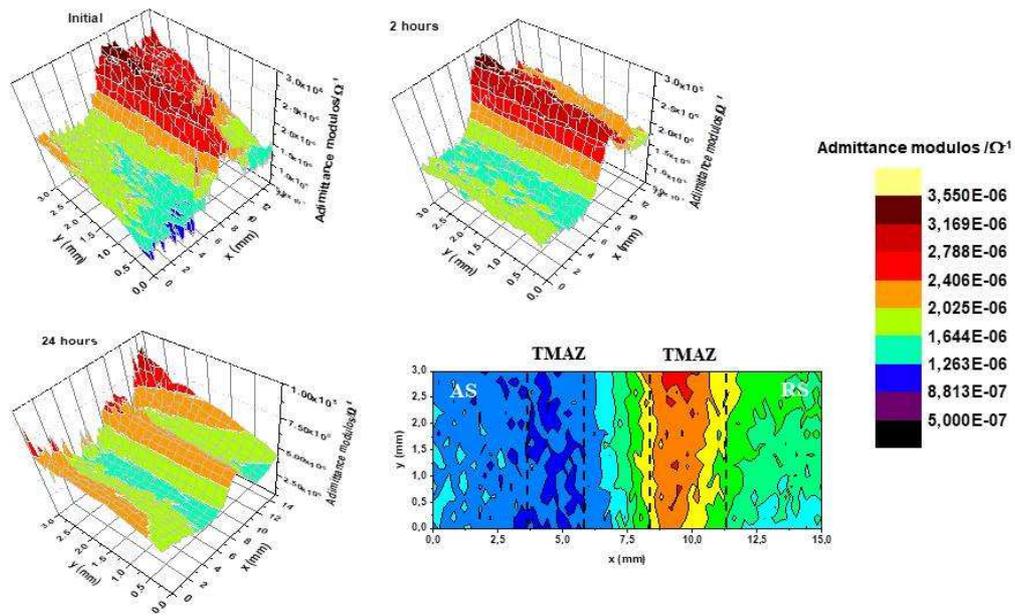
Figure. 12. LEIS maps of the surface of friction stir welded AA2024-T3 alloy showing the evolution of corrosion in Na_2SO_4 0.1M + NaCl 1mM solution. 2-D image corresponding to the diagram acquired after 24h, the dashed red lines indicate the presumed limit of the TMAZ. Acquisition frequency: 5Hz.

The LEIM diagrams presented in Figure 12 also revealed that the TMAZ(RS) region was the most susceptible region to SLC. Higher admittance modulus was recorded on

the TMAZ(RS) region compared with the rest of the weld for the test period presented, since higher admittance modulus corresponds to lower impedance and ultimately lower resistance to corrosion. The LEIM results are in good agreement with the SVET and agar visualization results confirming that the TMAZ(RS) is the most susceptible zone to SLC. The agreement between the SVET and LEIM results shows that the LEIS is a very useful technique in the characterization of the electrochemical responses across the weldment of an alloy. Interestingly, the complementarity of these techniques can be explained as follows. The frequency used for the LEIS mapping allows differentiating more clearly the kinetics of the electrochemical processes taking place at each region of the sample surface, as it may vary with the microstructure, which, as previously demonstrated, is strongly affected by the FSW process, however it does not allow differentiating cathodic and anodic domains, whereas the SVET allowed to measure the dc-contribution of the current (contribution which is hardly measurable with LEIS), allowing to clearly identify anodic and cathodic sites.

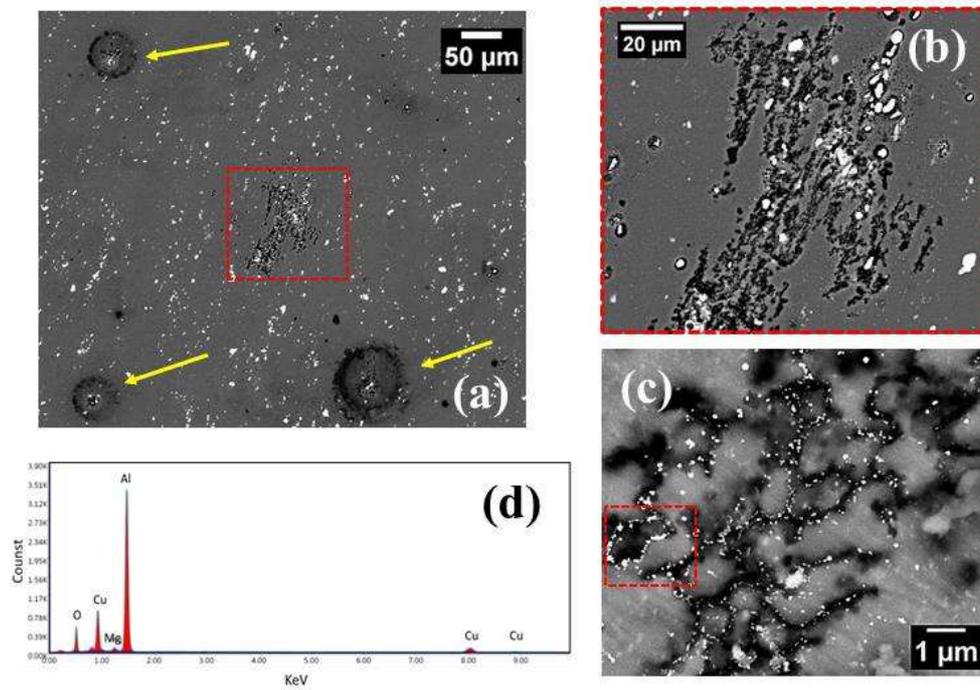
Figure. 15. SEM images (a-c) of the TMAZ(RS) of the friction stir welded AA2024-T3 alloy after immersion in NaCl solution for 12 hours showing different corrosion features. (d) EDS spectrum of the framed region depicted in (c).

weldment. As evident, the attack also propagated through the grain boundaries after the initiation of attack at the clustered sites. Another interesting finding was the re-deposition of Cu at the grain boundaries in the corroded region (Figures 15(c) and (d)). This re-deposition possibly enhanced the growth of the SLC through the interactions of the cathodic re-deposited Cu and the adjacent matrix. Furthermore, it is also possible that galvanic interactions occurred between the particle clusters and the particle-free regions to promote the formation of SLC.
